ATTACHMENT F

November 15, 2019 March 6, 2022 Revised

Re: 206 Sequoia Avenue Redwood City, CA

Tree Description/Observation

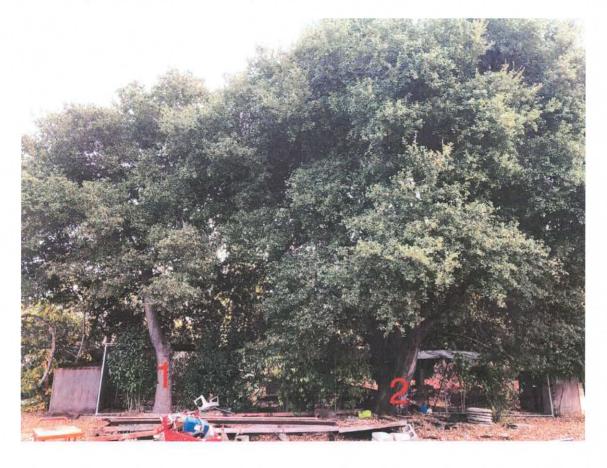
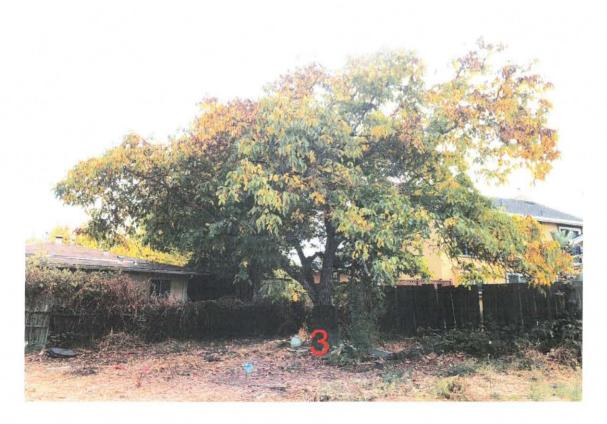
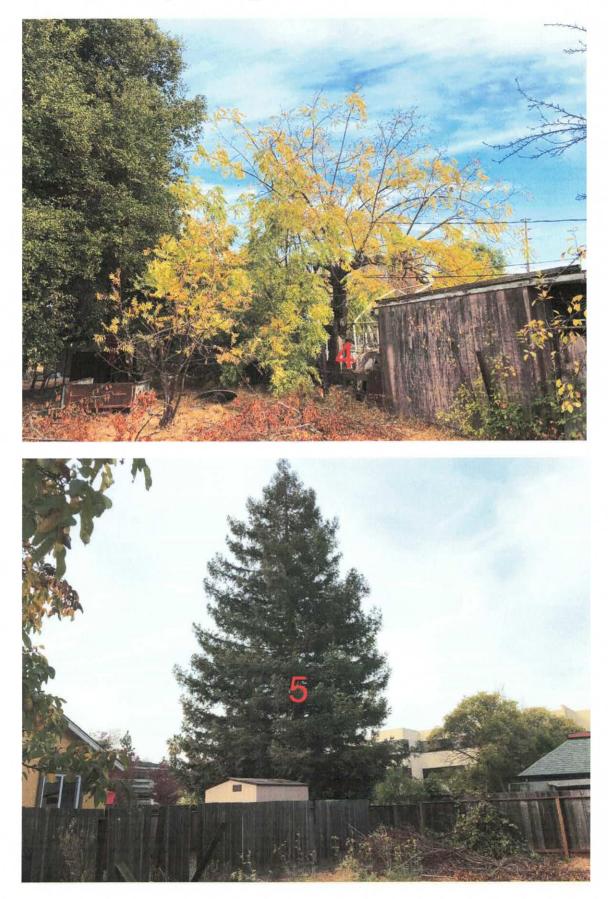
Grows to a phototropic lean away from larger live oak. Minor accumulation of interior deadwood due to dense crown. The TPZ is 8-feet.

Crown exhibits normal vigor with a moderate accumulation of deadwood. Six primary scaffold limbs exhibit weak attachments. Two 1-inch diameter pipes are embedded in main crotch. The TPZ is 18-feet.

Crown exhibits a moderate accumulation of interior deadwood. Measured just above graft. Located in proposed building foundation.

TPZ 12-feet. Proposed construction excavation is 10-feet from fence and should impact less than 25 percent of root environment.

TPZ 12-feet. Minimal impacts anticipated within TPZ. Proposed excavation should encroach no closer than 15-feet.
