To: Planning Commission

From: Public Member Crystal Chaix (neighbor)

Subject: Questions, comments and concerns regarding Agenda item 4 on the November 12, 2025, Planning Commission Meeting

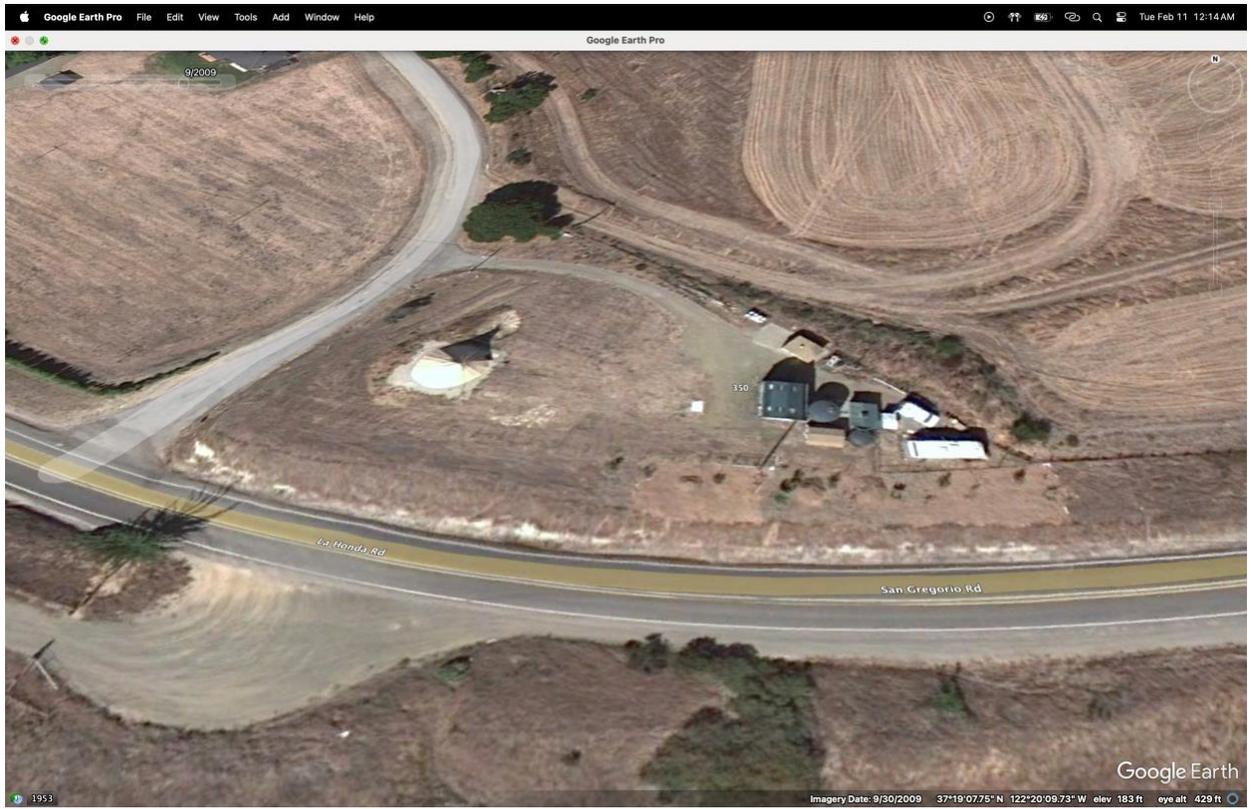
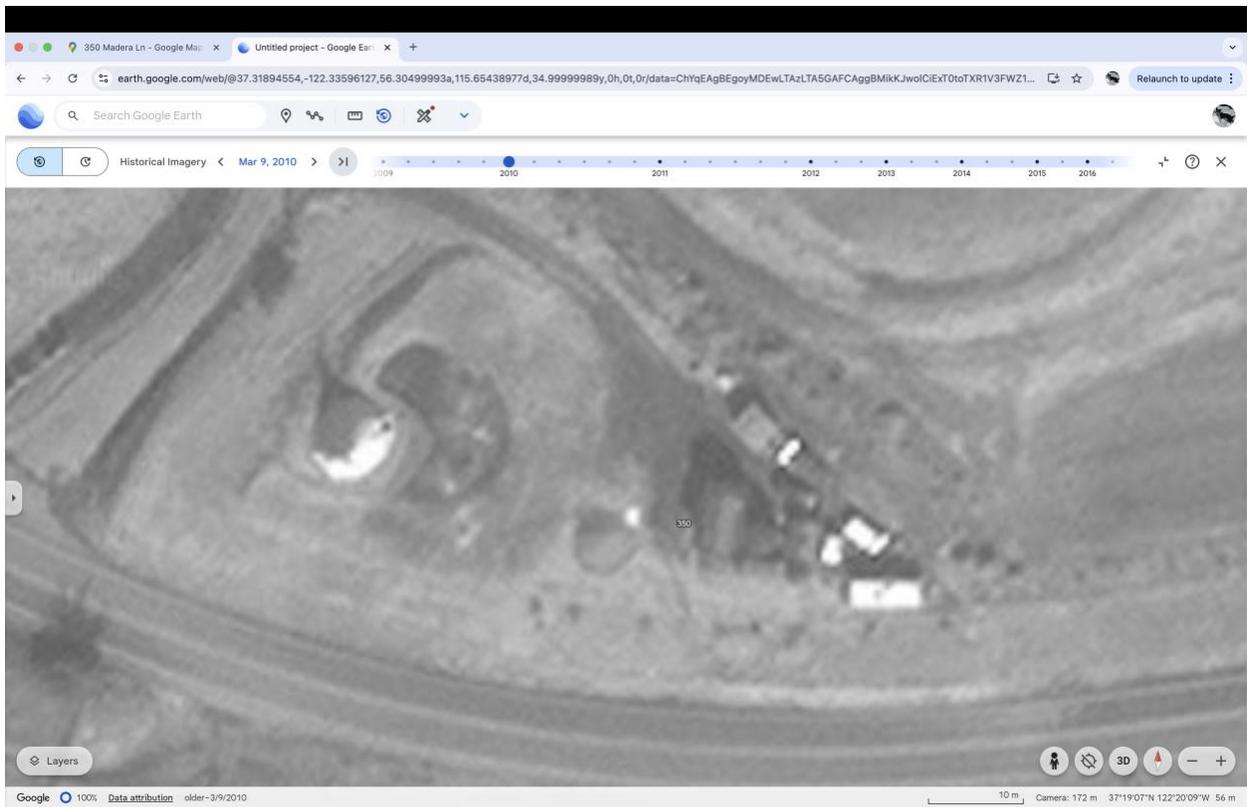
On page 7, It says “The existing pond on the property was created by the owner by grading less than 150 c.y. per year. I have pictures to prove otherwise. Please see the attached photos. On September 30, 2009, there was no grading. A little over 5 months, from the photo taken on March 9, 2010, all the grading had taken place without a permit. Not over the years as previously indicated by the applicant. Both photos are from Google Earth Pro.

Under Hydrology and Water Quality, 10.a. discussion, “The site contains a man-made pond that was created by the owner by grading less than 150 cu. yd. every year (threshold for not requiring a Grading Permit). Since this is not the case, shouldn’t this be a violation all on its own?

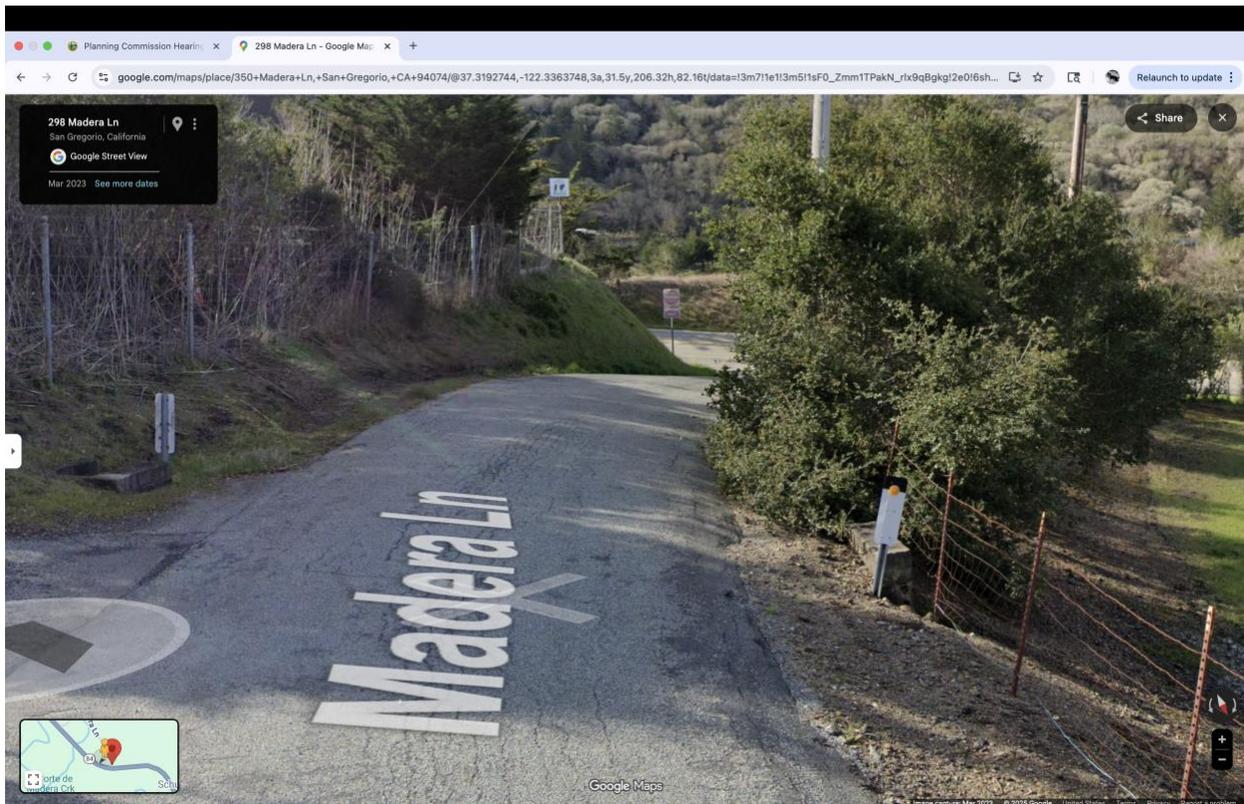
Looking at the photo below, you will see that the runoff flows west down the applicant’s driveway and into the ditch. The ditch has a concrete culvert that runs under Madera Lane with the outlet flowing into my crop of hay.

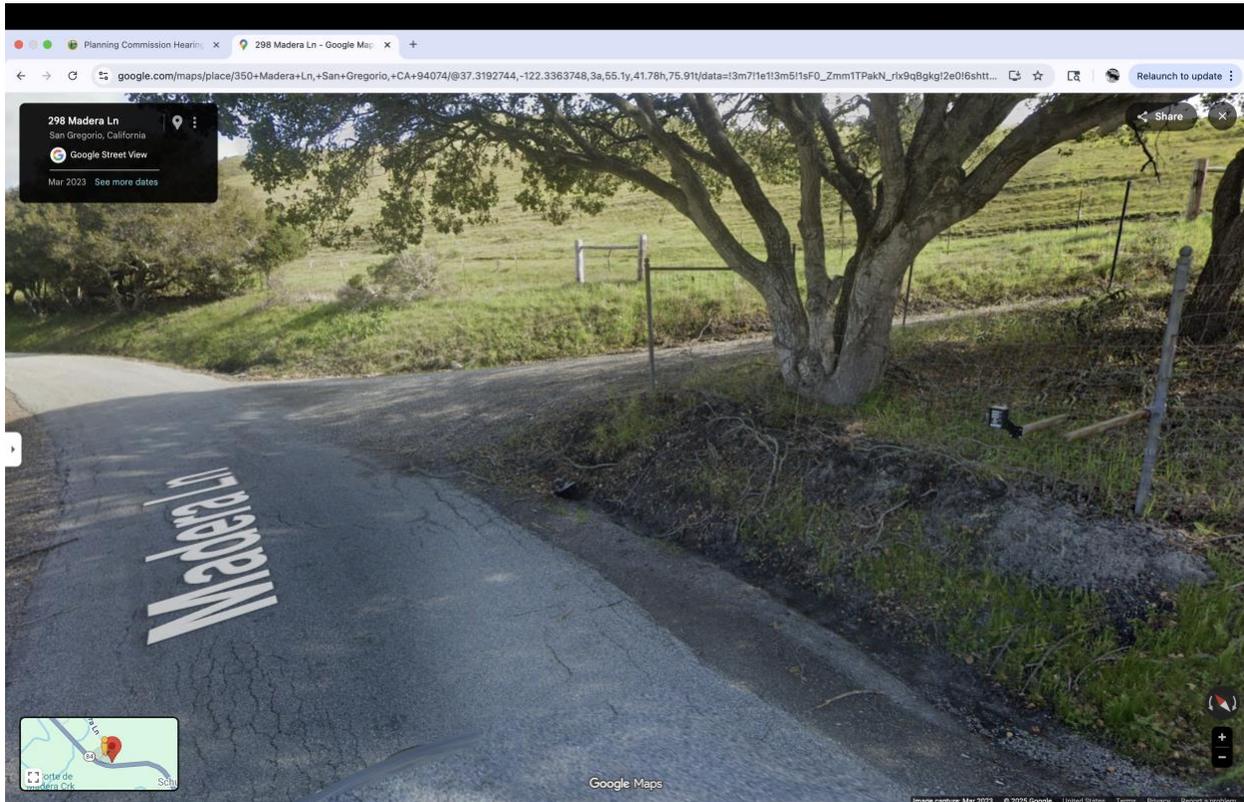
On the other side of the driveway, there is a culvert that runs along Madera Lane to the west. It too flows into a culvert and flows into the Corde Madera Creek.
