Subject: Aquatic Resource Delineation Letter Report for a Residential Parcel at 779 San Carlos Avenue,

El Granada, San Mateo County, California; APN No. 047-105-020

AQUATIC RESOURCE DELINEATION

779 San Carlos Avenue, El Granada San Mateo County, California

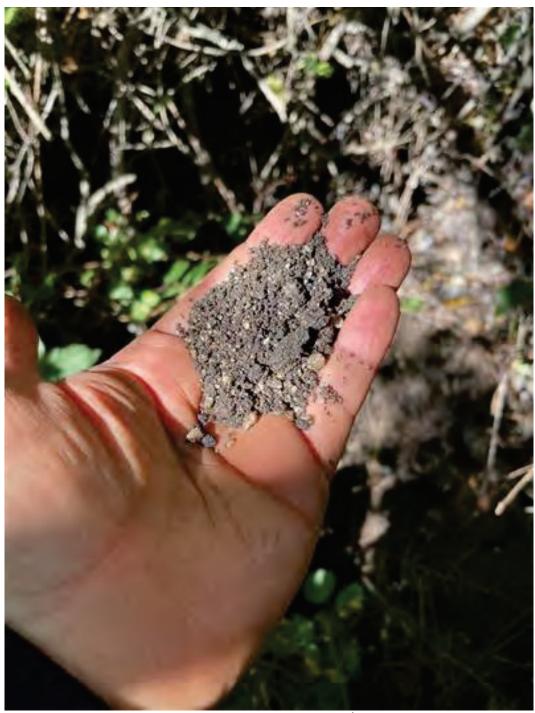
SP-1: From 30"-40", loamy sand with pebbles, 10YR3/1.

The matrix color for SP-1 and SP-3 ranged from 10YR 2/1, 3/1 and 3/2. At SP-1 redoximorphic features in the form of reduced iron was found within a 2" layer of silty loam from 28"-30". It should be noted a 2" layer of redox at this depth does not meet any of the hydric soil indicators. SP-2 and SP-4 matrix color ranged from 10YR 3/2 and 3/3 with no redoximorphic features.

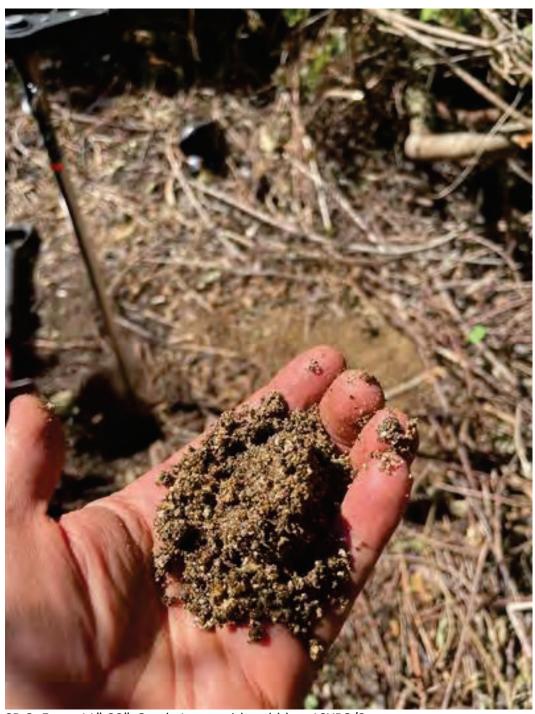
SP-2: From 11"-29", Sandy Loam with pebbles, 10YR3/3.

SP-2 and SP-4 were taken on the hillslope. Soil texture throughout the profile varied from a Silty Loam near the surface to Loamy Sand. <u>No restrictive</u> horizon was observed from 0"-34". NRCS soils mapping for this area indicates these soils form on hills, support clay from the B-C horizon
