**Subject: Aquatic Resource Delineation Letter Report for a Residential Parcel at 779 San Carlos Avenue, El Granada, San Mateo County, California; APN No. 047-105-020**

# **AQUATIC RESOURCE DELINEATION**

**779 San Carlos Avenue, El Granada  
San Mateo County, California**

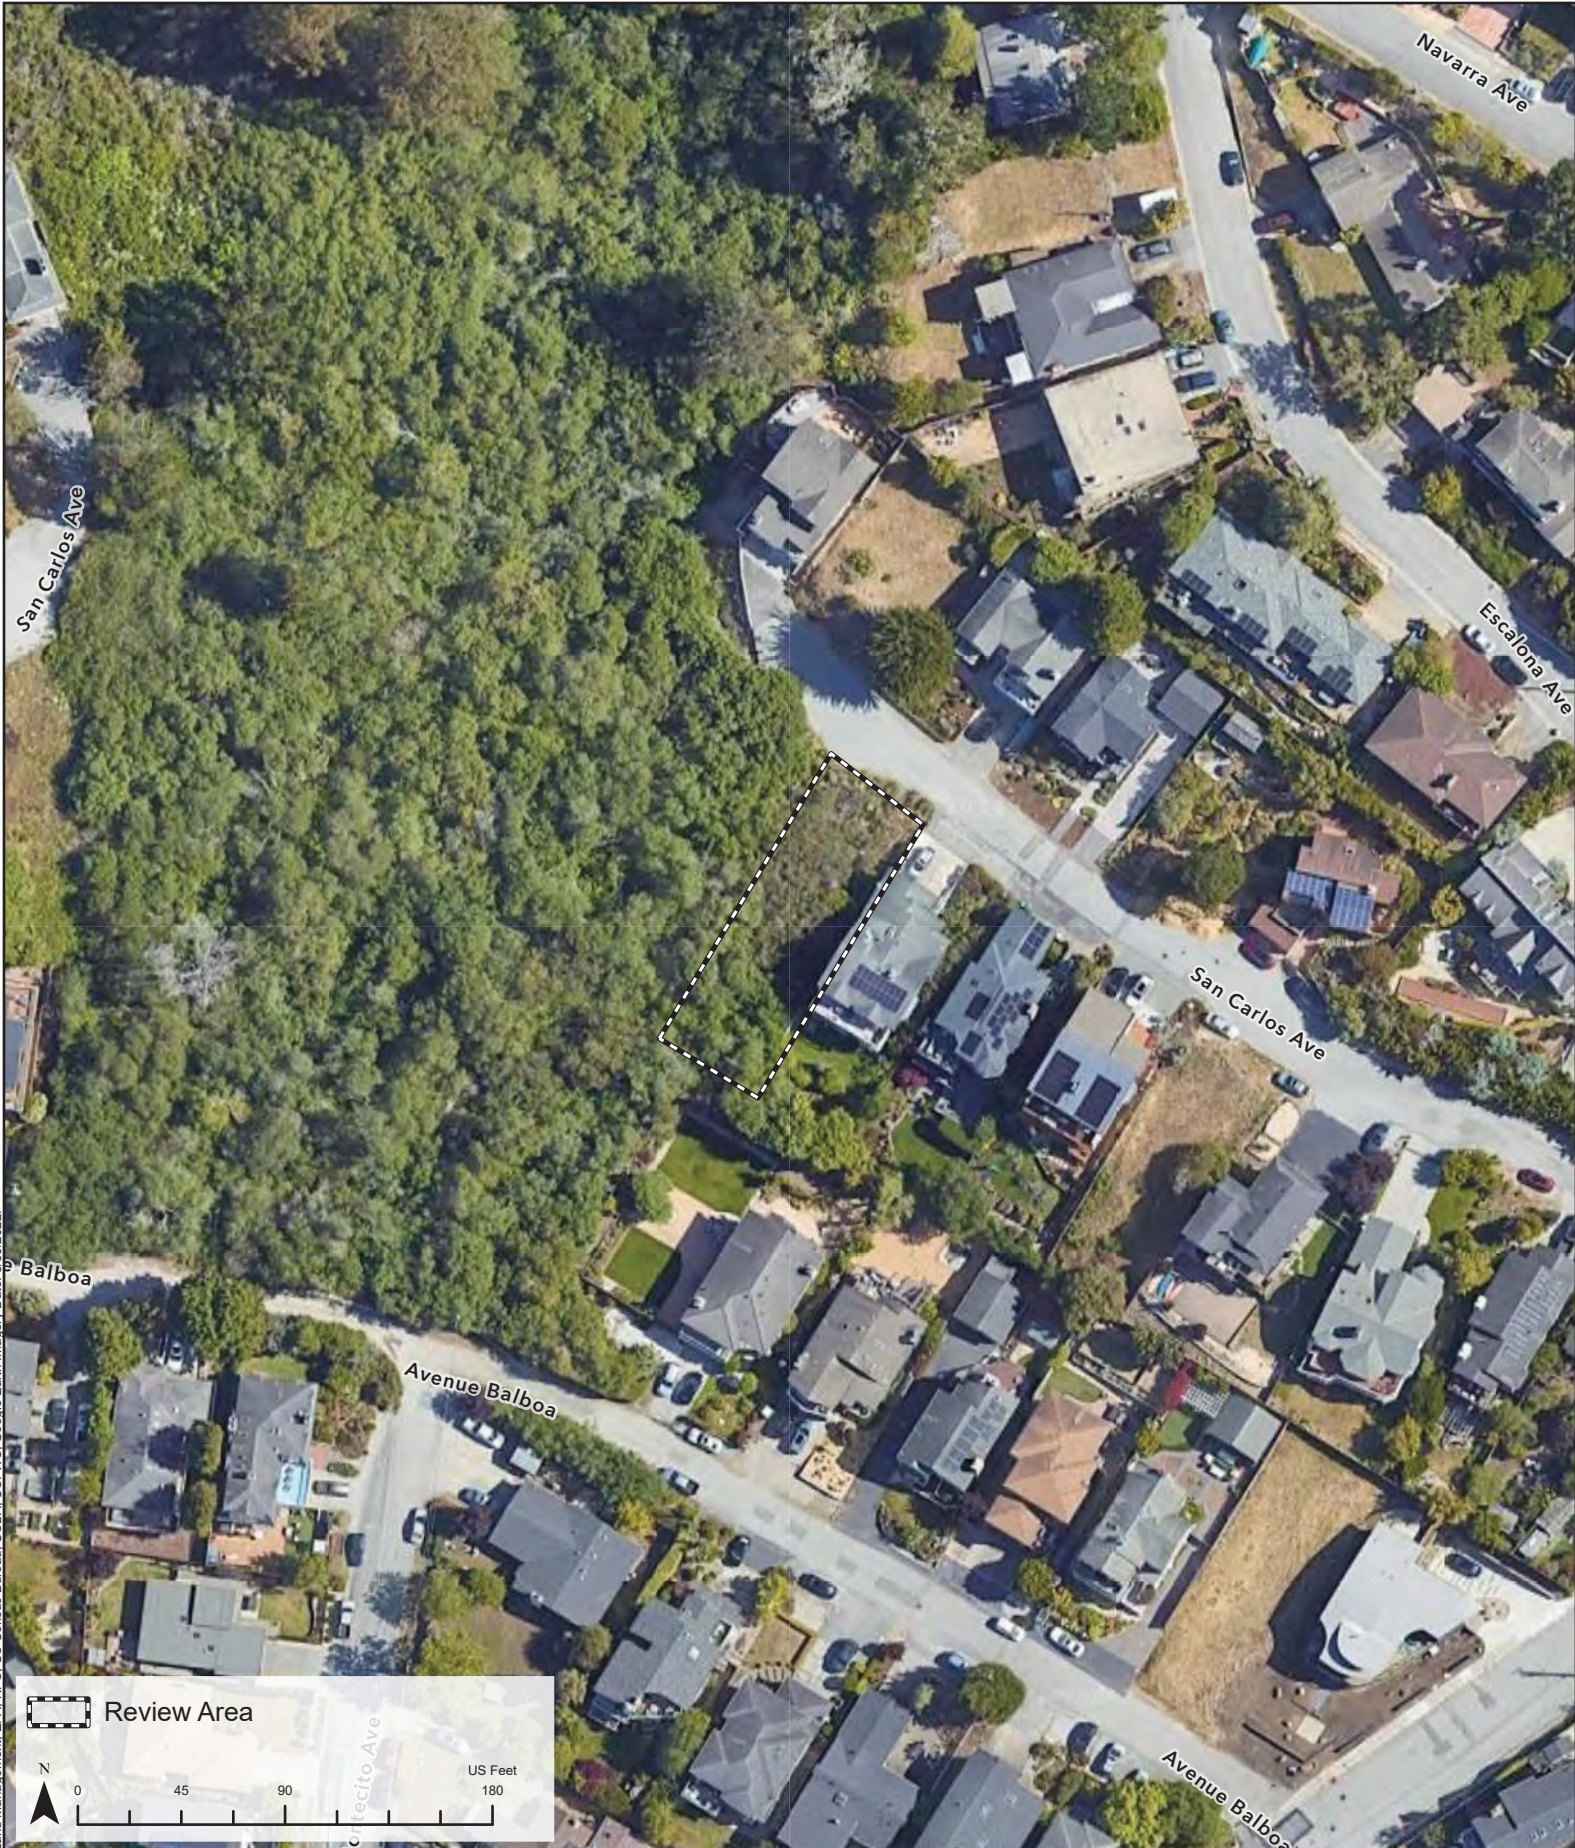
**Figure 3. Aerial Image of the Review Area**  
Proposed Single-Family Residence Project  
779 San Carlos Avenue, El Granada, San Mateo County

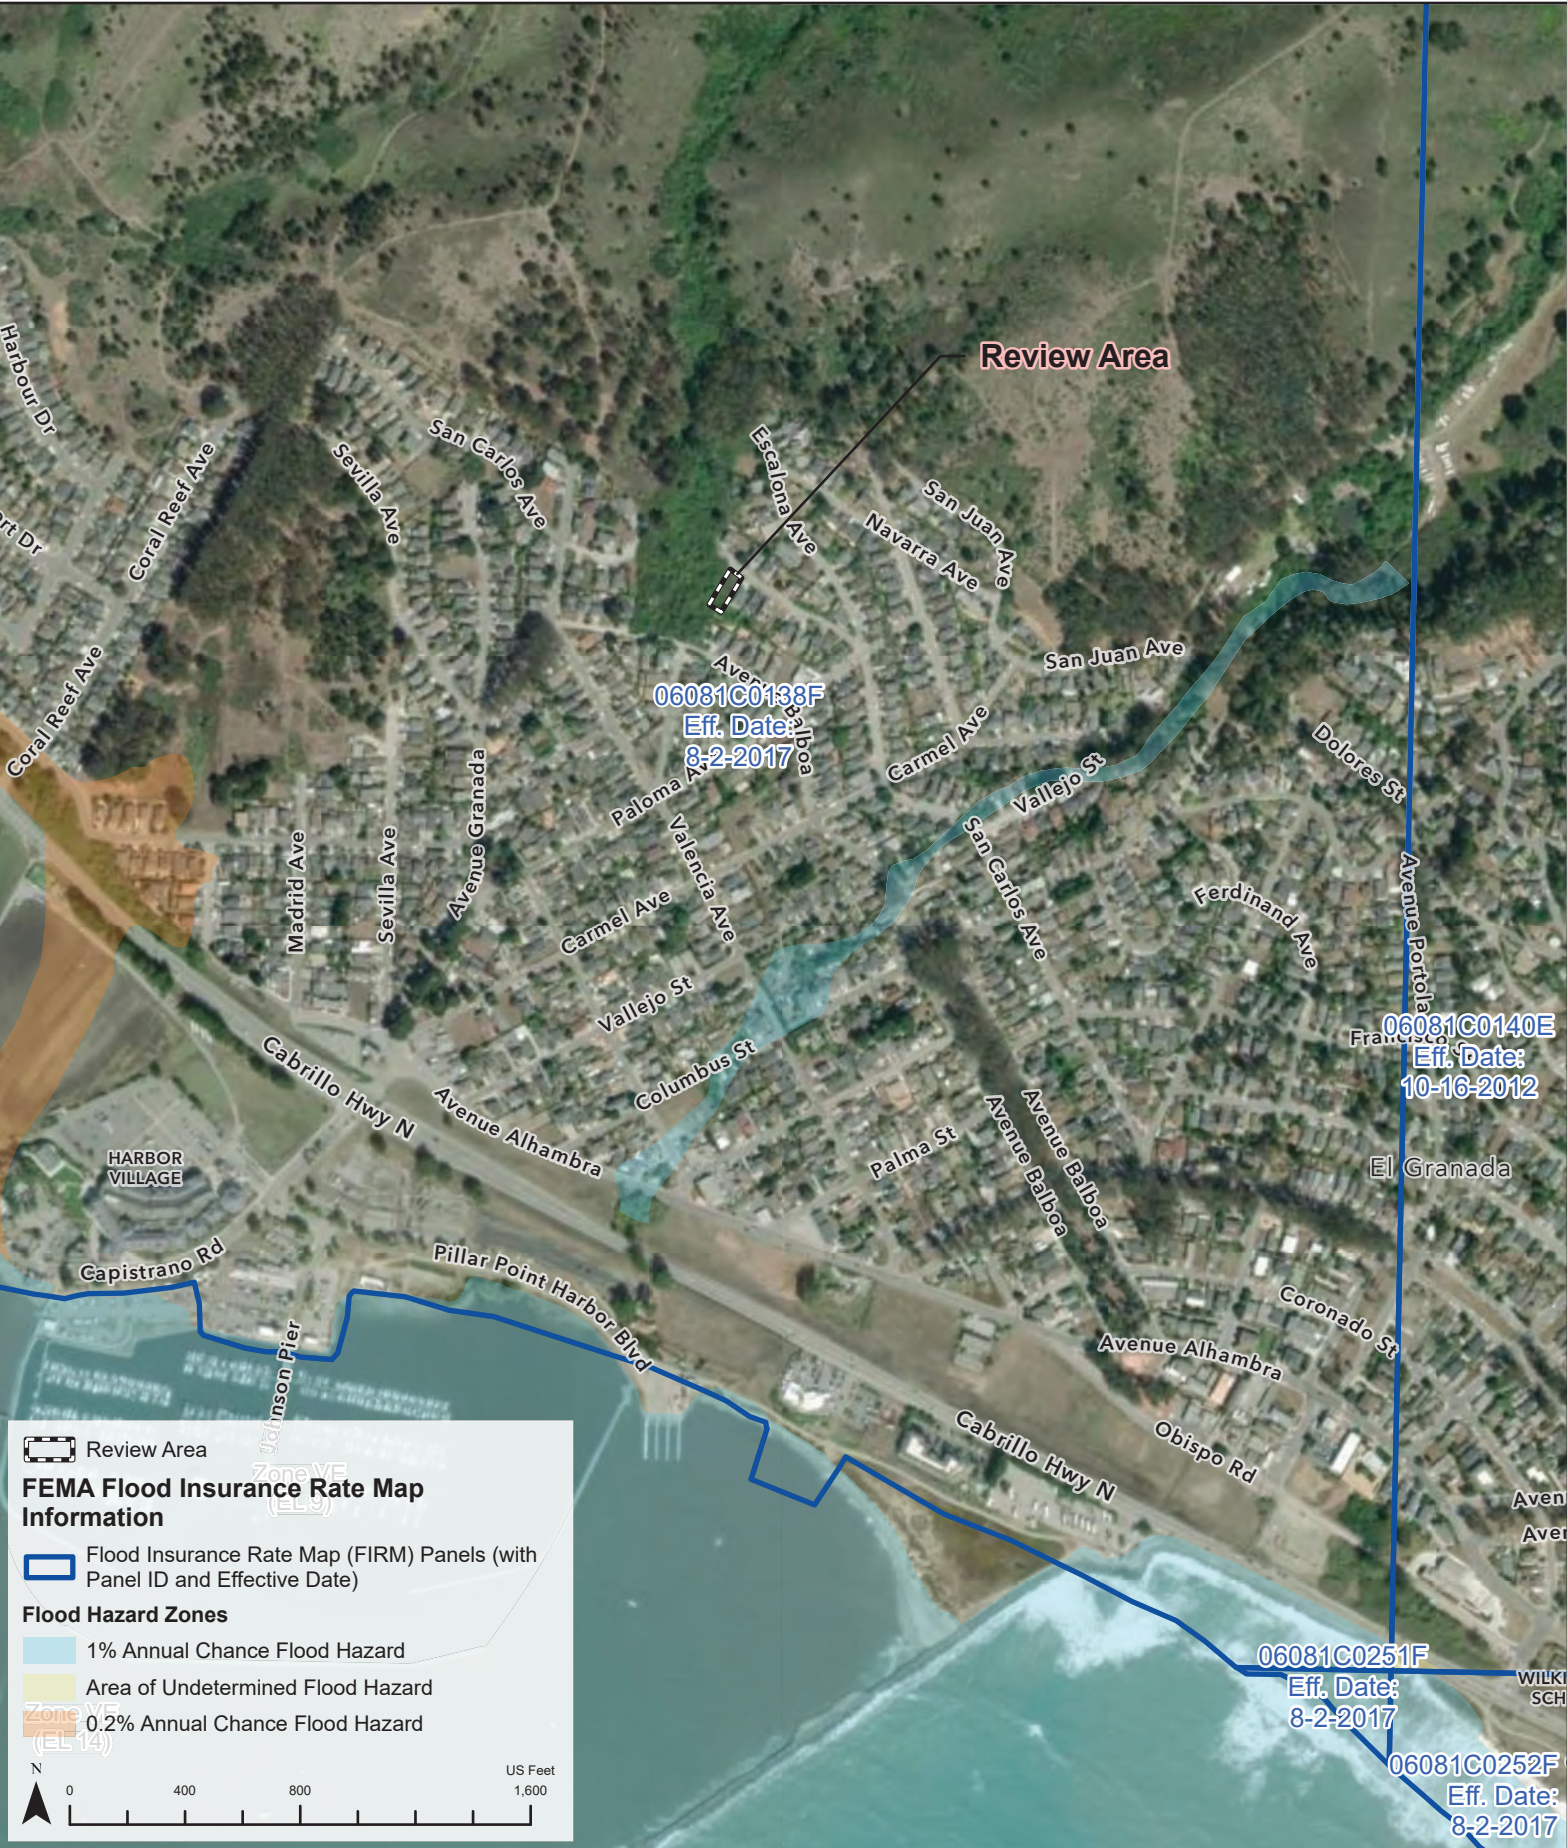
No primary hydrologic indicators were observed, no surface water, saturation or a water table was observed, and the Review Area is not situated within a flood plain. Within SP-1 and SP-3 one secondary indicator, FAC-Neutral Test (D5) was recorded. Refer to Figure 4 FEMA Flood Zone Mapping for the Review Area flood hazard zone.

**Figure 4. FEMA Flood Zone Mapping**  
Proposed Single-Family Residence Project  
779 San Carlos Avenue, El Granada, San Mateo County

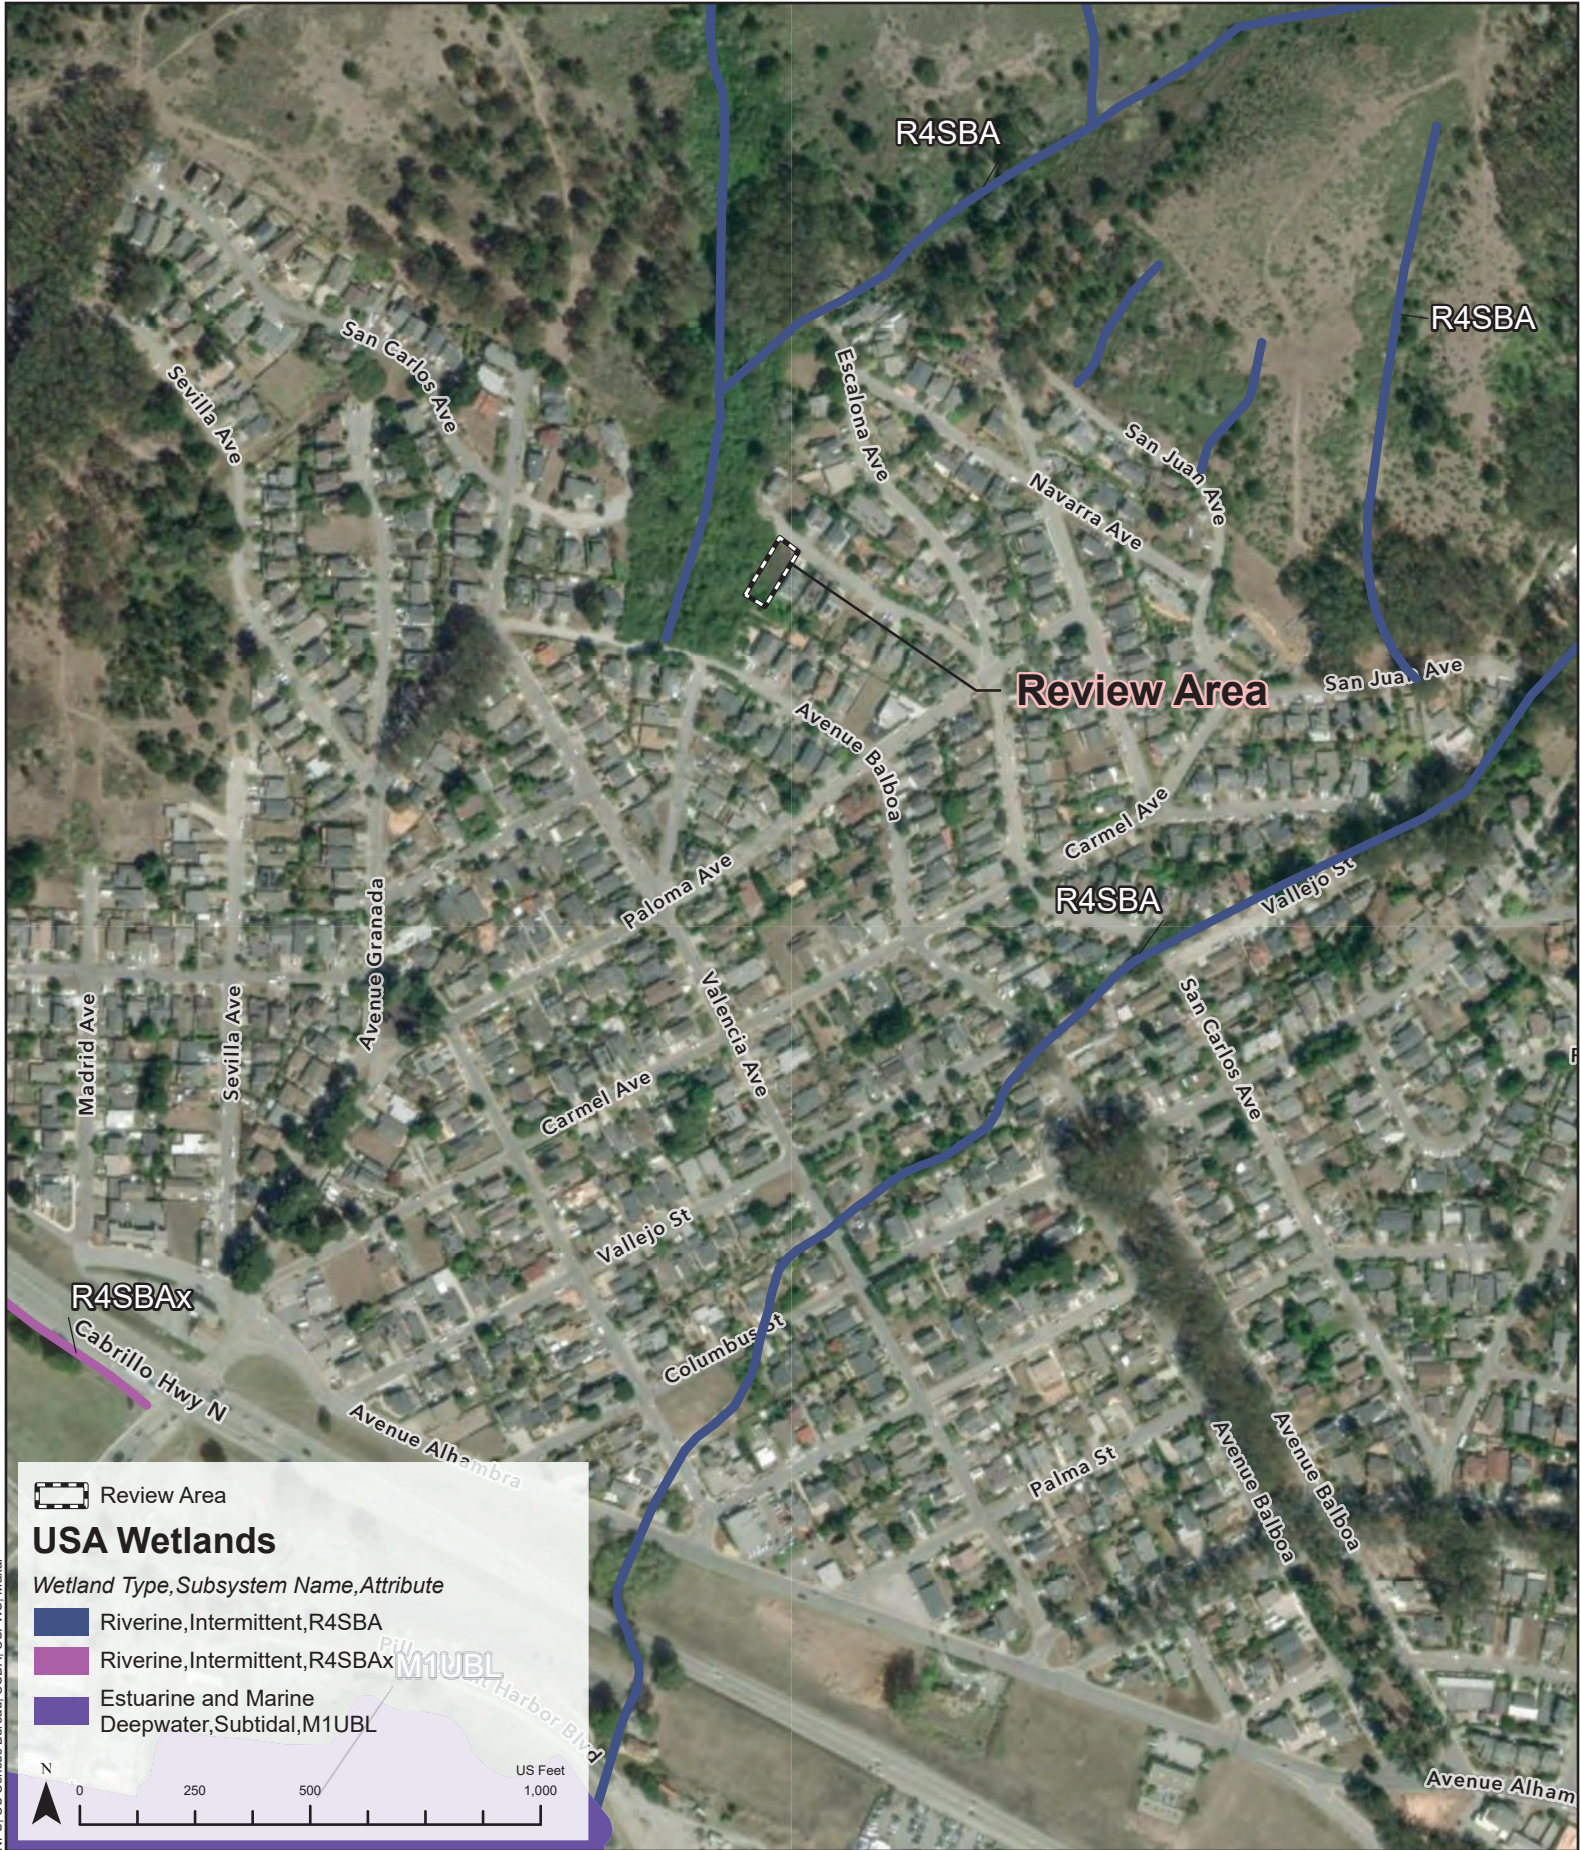
**Figure 6. USFWS National Wetlands Inventory Mapping**  
Proposed Single-Family Residence Project  
779 San Carlos Avenue, El Granada, San Mateo County

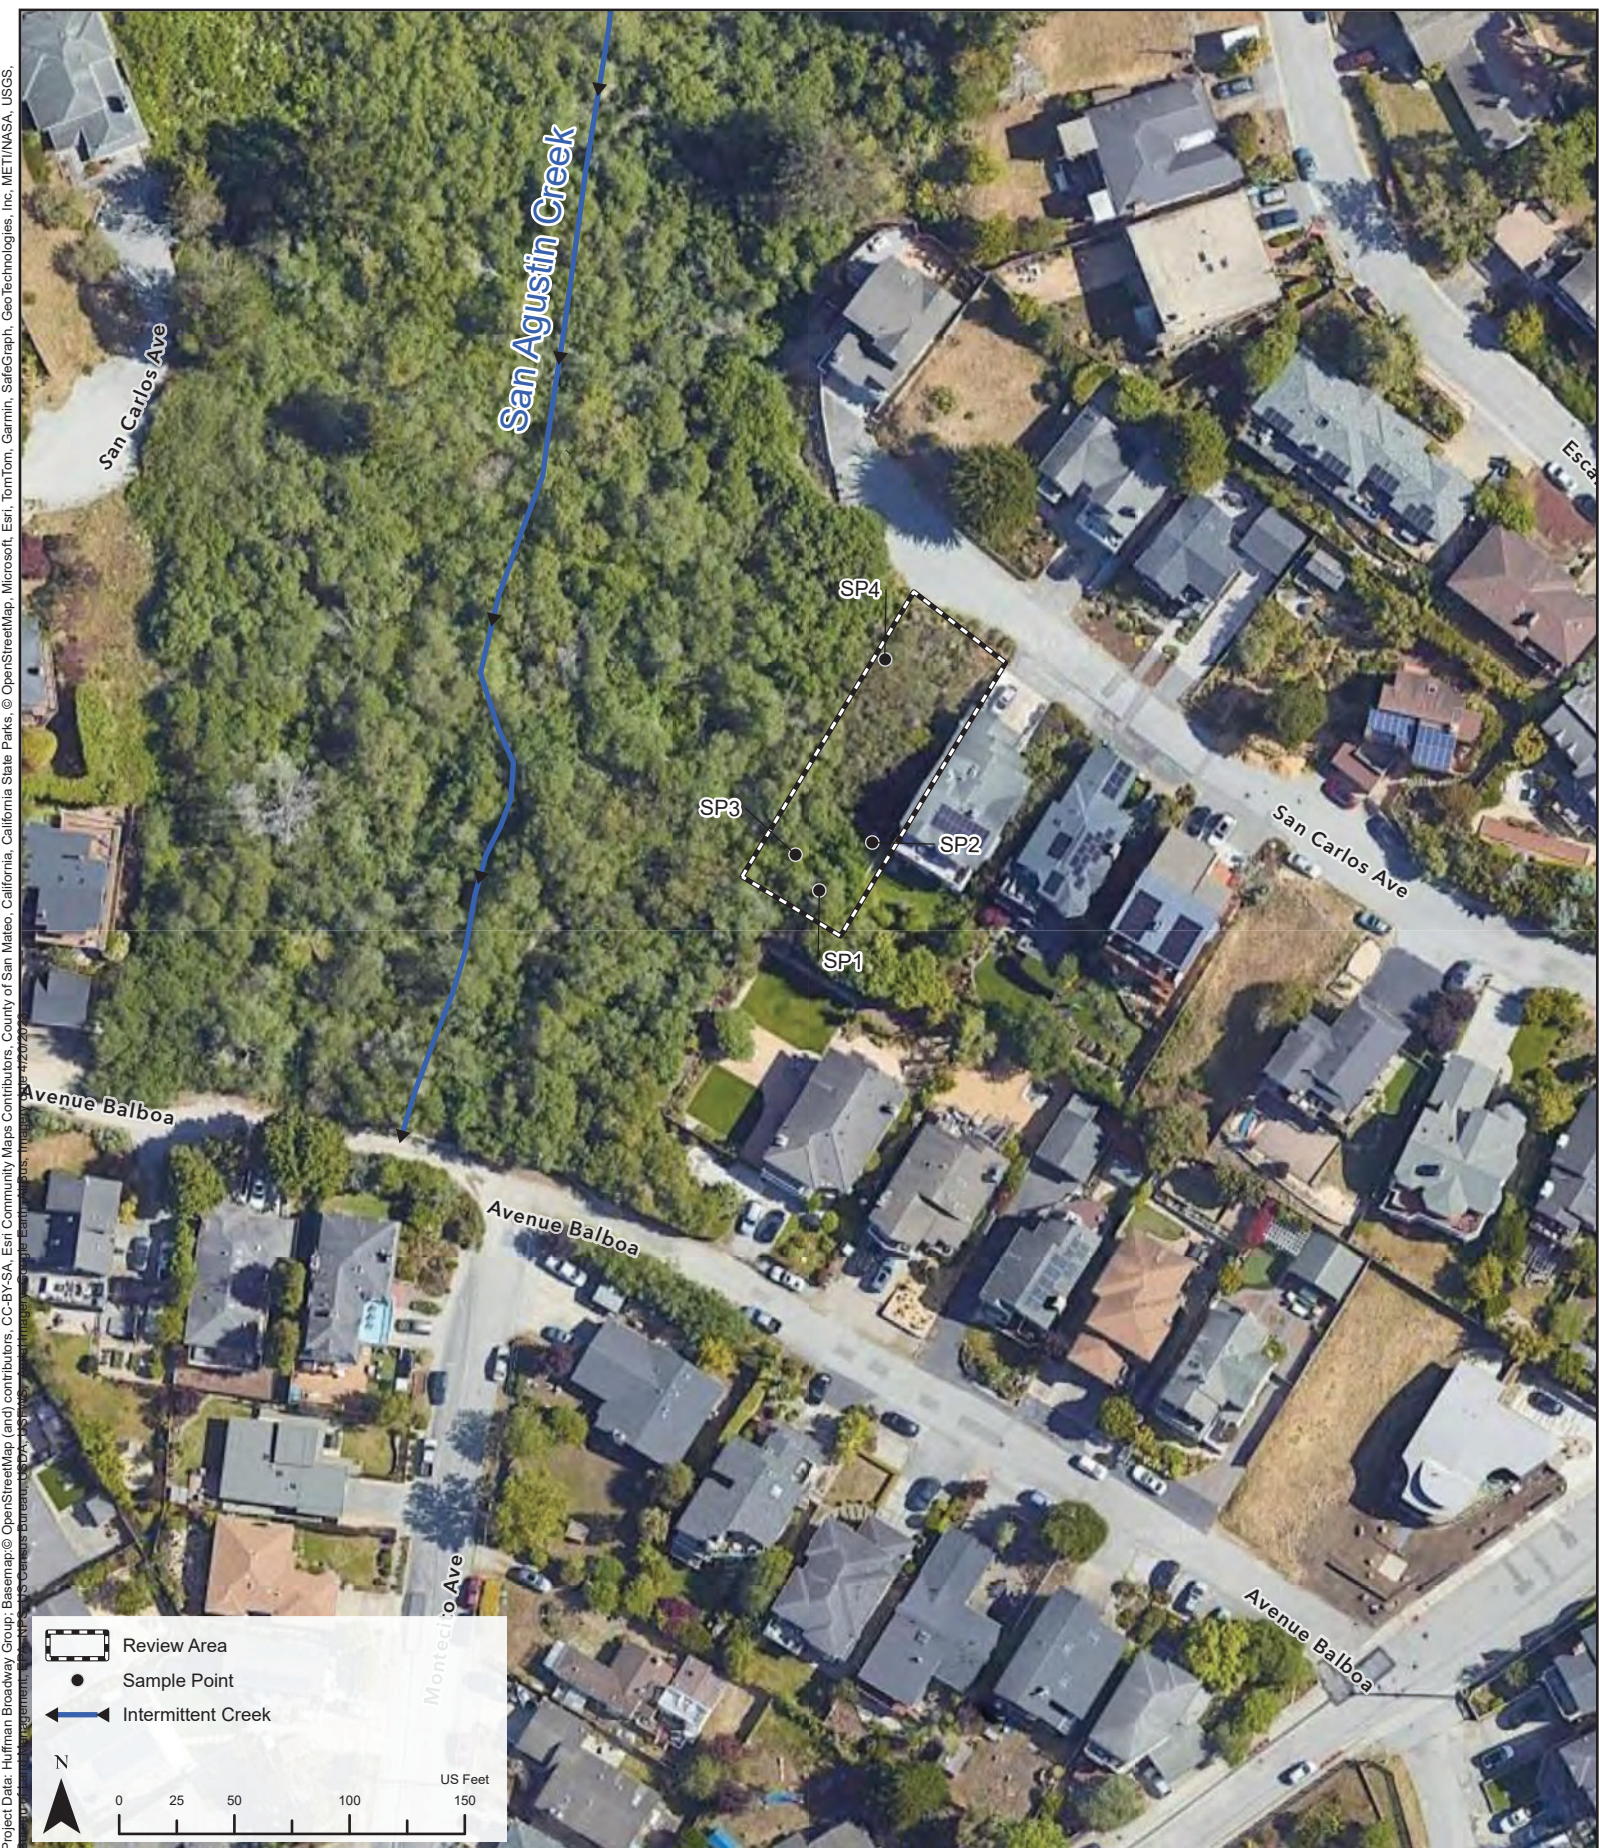
The following sections discuss hydrophytic vegetation, hydric soil, and wetland hydrology conditions observed at the Review Area. Sample Point locations are shown on Appendix 1, Figure 7, Wetland Determination Data Forms documenting this information are in Appendix 2, and representative photographs of the Review Area are provided in Appendix 3.

Vegetation, soil, and hydrology observations were made at four (4) sample point locations. Two of the sample points, SP-1 and SP-3 were positioned on a flat landform feature where the slope converged, and sample points SP-2 and SP-4 were taken on the hillslope which dominated 90% of the Review Area.

**Figure 7. Aquatic Resource Delineation**  
 Proposed Single-Family Residence Project  
 779 San Carlos Avenue, El Granada, San Mateo County

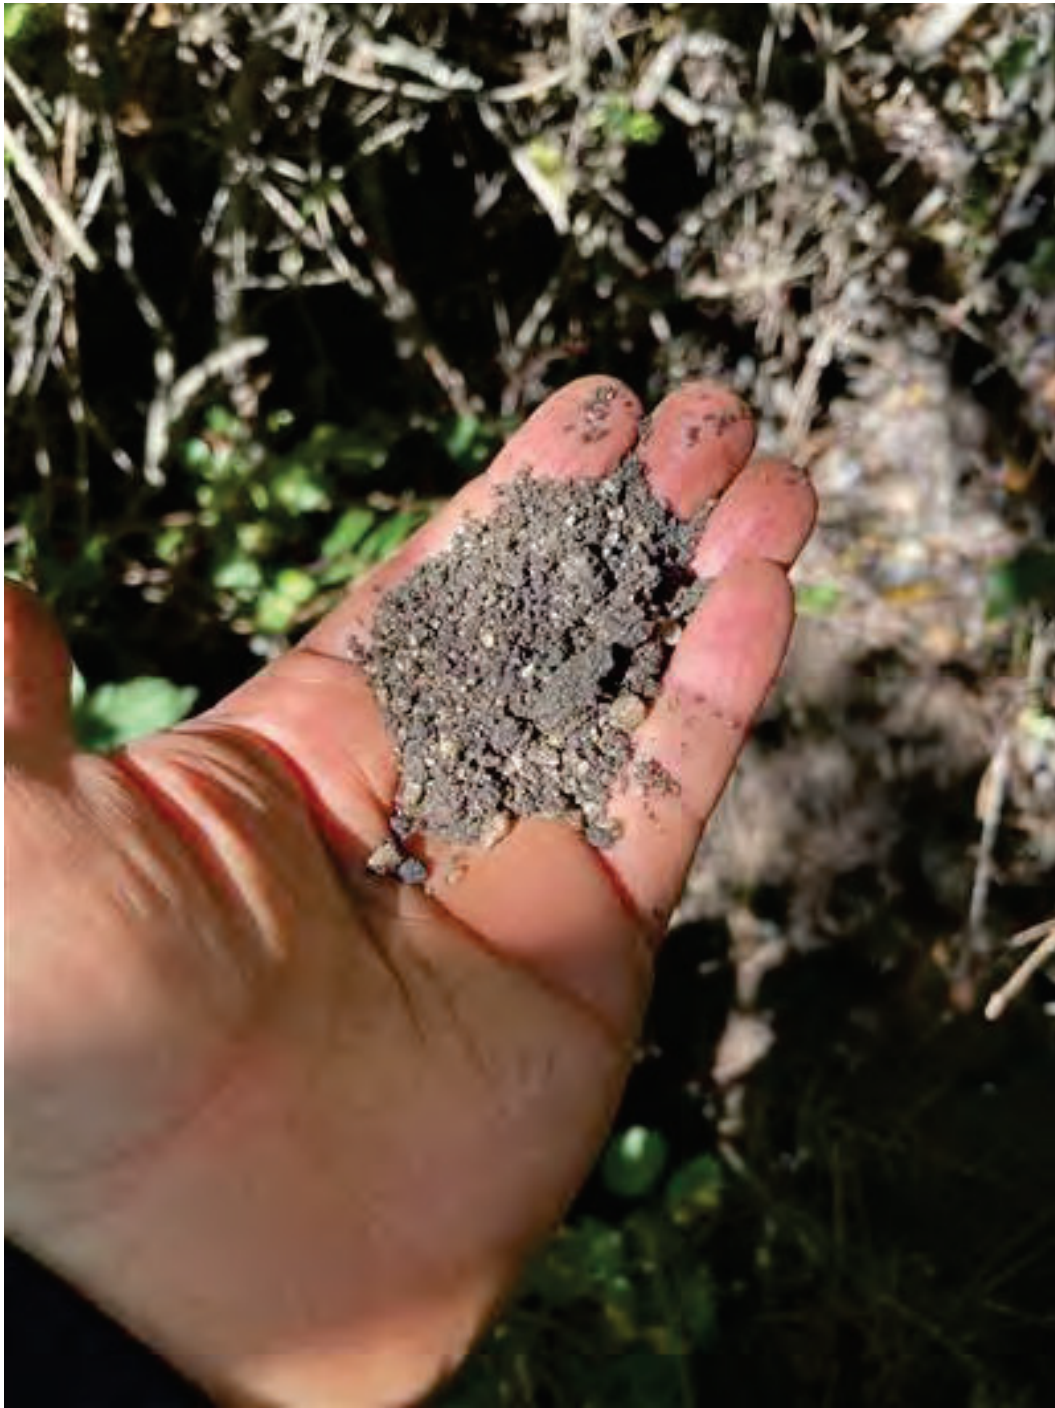
The matrix color for SP-1 and SP-3 ranged from 10YR 2/1, 3/1 and 3/2. At SP-1 redoximorphic features in the form of reduced iron was found within a 2" layer of silty loam from 28"-30". It should be noted a 2" layer of redox at this depth does not meet any of the hydric soil indicators. SP-2 and SP-4 matrix color ranged from 10YR 3/2 and 3/3 with no redoximorphic features.

SP-1: From 30"-40", loamy sand with pebbles, 10YR3/1.

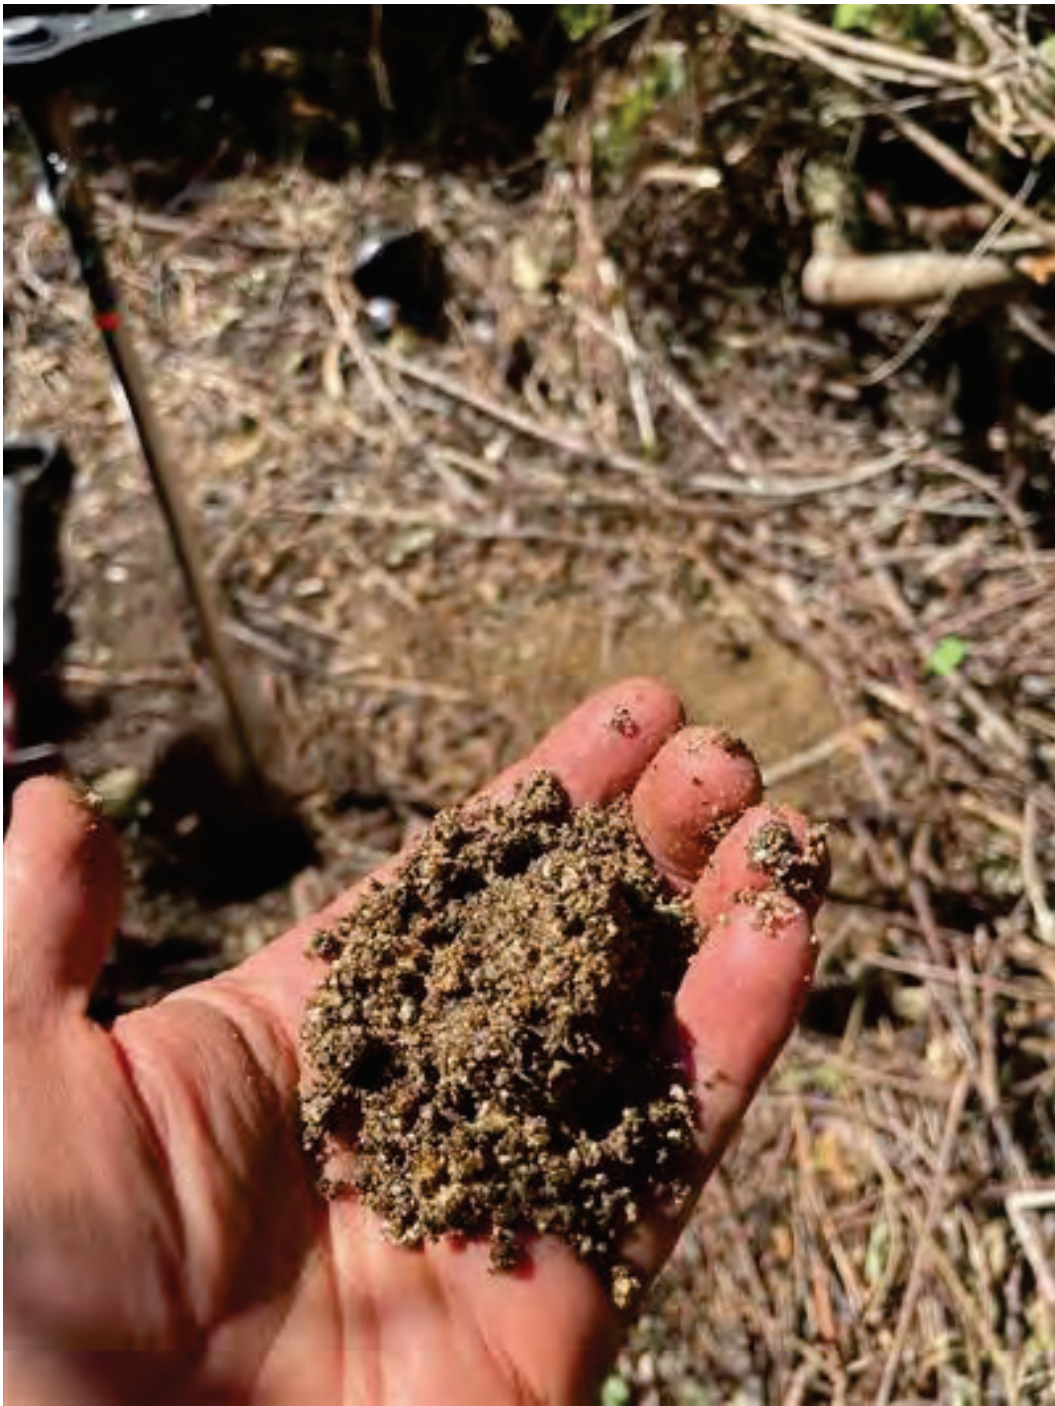
SP-2 and SP-4 were taken on the hillslope. Soil texture throughout the profile varied from a Silty Loam near the surface to Loamy Sand. No restrictive horizon was observed from 0”-34”. NRCS soils mapping for this area indicates these soils form on hills, support clay from the B-C horizon

SP-2: From 11"-29", Sandy Loam with pebbles, 10YR3/3.

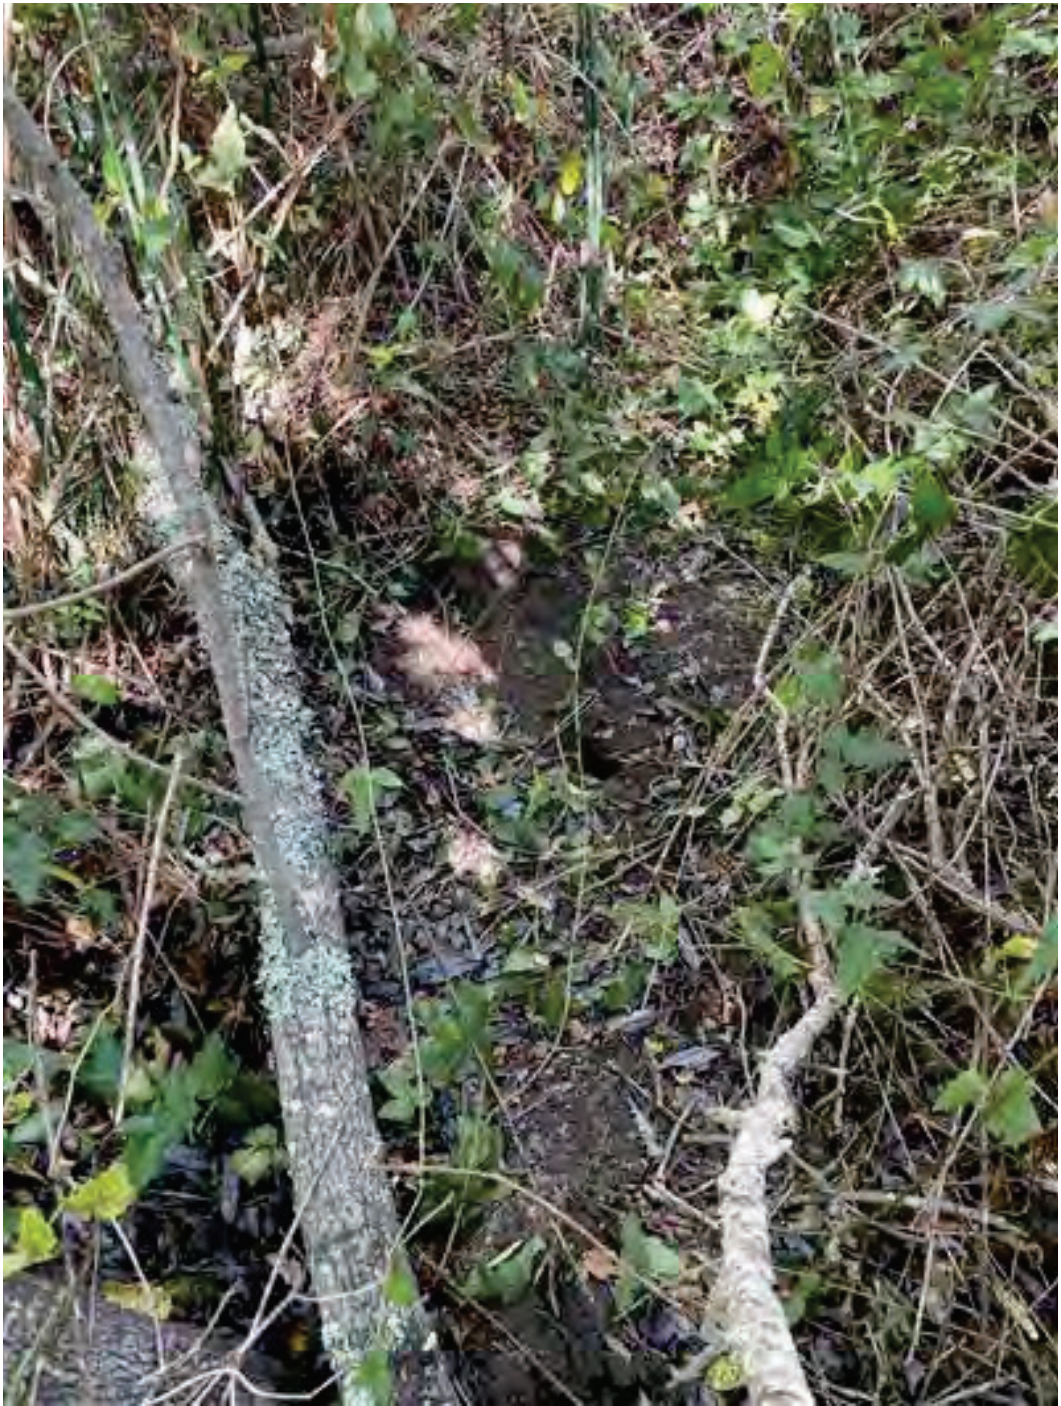
SP-1 and SP-3 were taken on a landform described as flat where the hillslope converged to this flat topographic area. SP-1 and SP-3 are located uphill from the creek well above its flood plain. Soil texture throughout the profile varied from a Loam near the surface to a Loamy Sand and Silty Loam. No restrictive horizon was observed. NRCS soils mapping for this area indicates that these soils formed on a flood plain or alluvial fan and have a restricted layer at depths of 80”.

SP-3: Flat topography, augur hole shown in photo dug to 34".

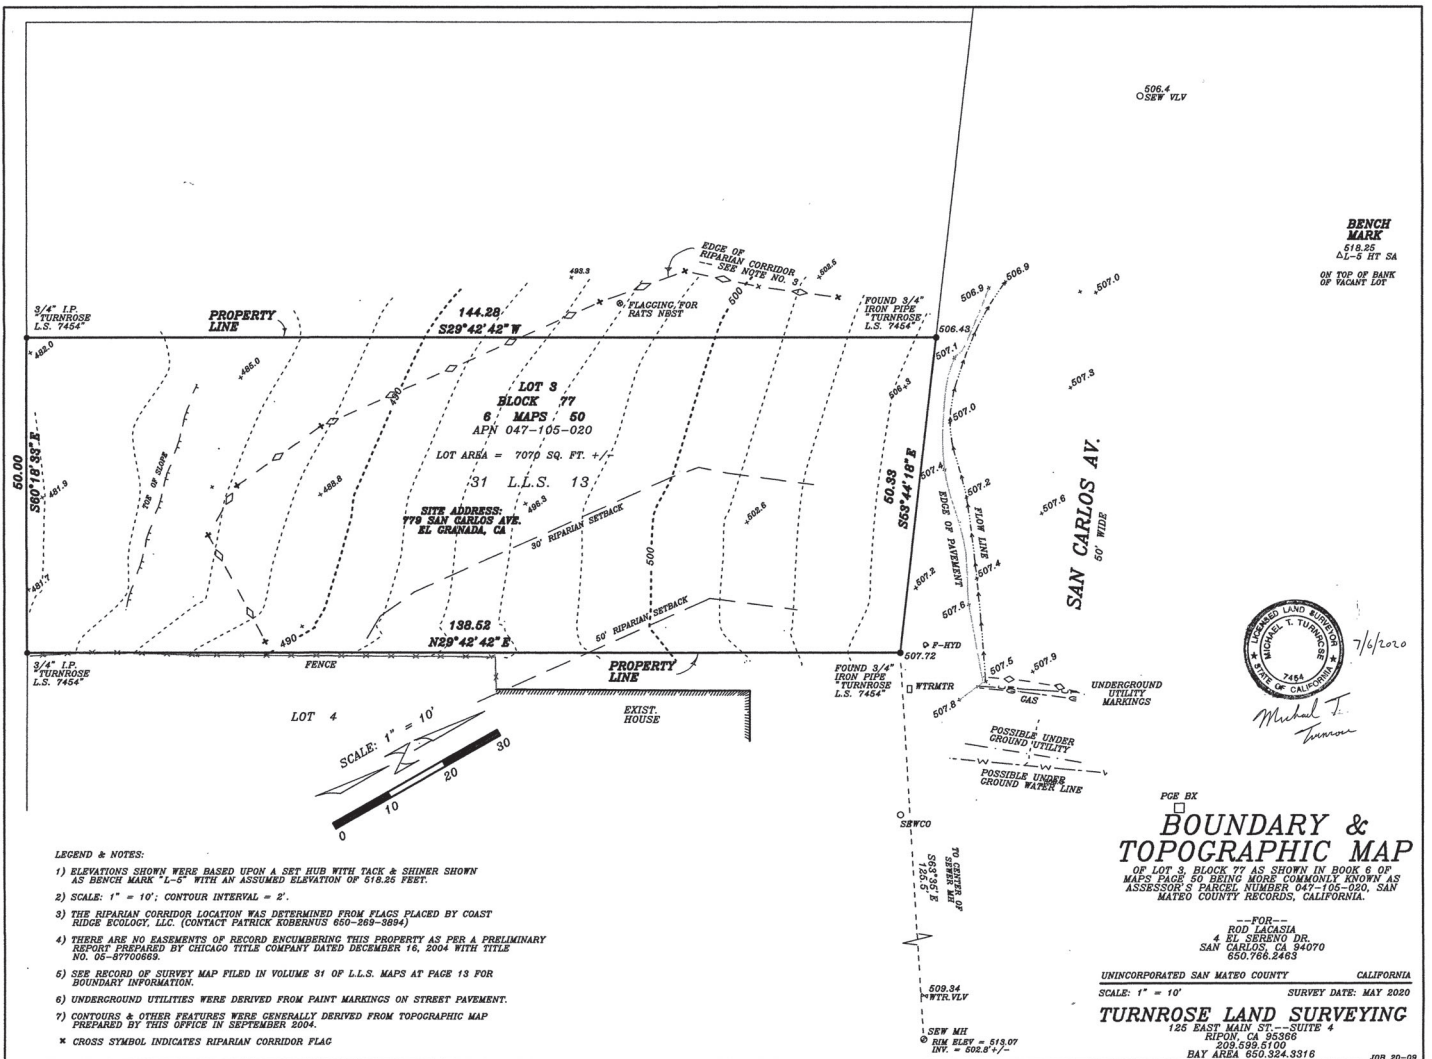
### **Turnrose Land Surveying Topographic Map**

Based on the site visit and review of the topographic map prepared by Turnrose Land Surveying company dated July 6, 2020, the majority of the Review Area slopes from the boundary along San Carlos Avenue south/southwest at a 5.5:1 / 18% slope. Approximately 20-25 linear feet from the southern boundary, the slope flattens as shown on the topographic map and confirmed in the field. The topographic survey of the Review Area is provided in Appendix 4.
