# TUNITAS CREEK BEACH IMPROVEMENT PROJECT

## **PRESENTATION TO THE SAN MATEO COUNTY BOARD OF SUPERVISORS**

February 2021

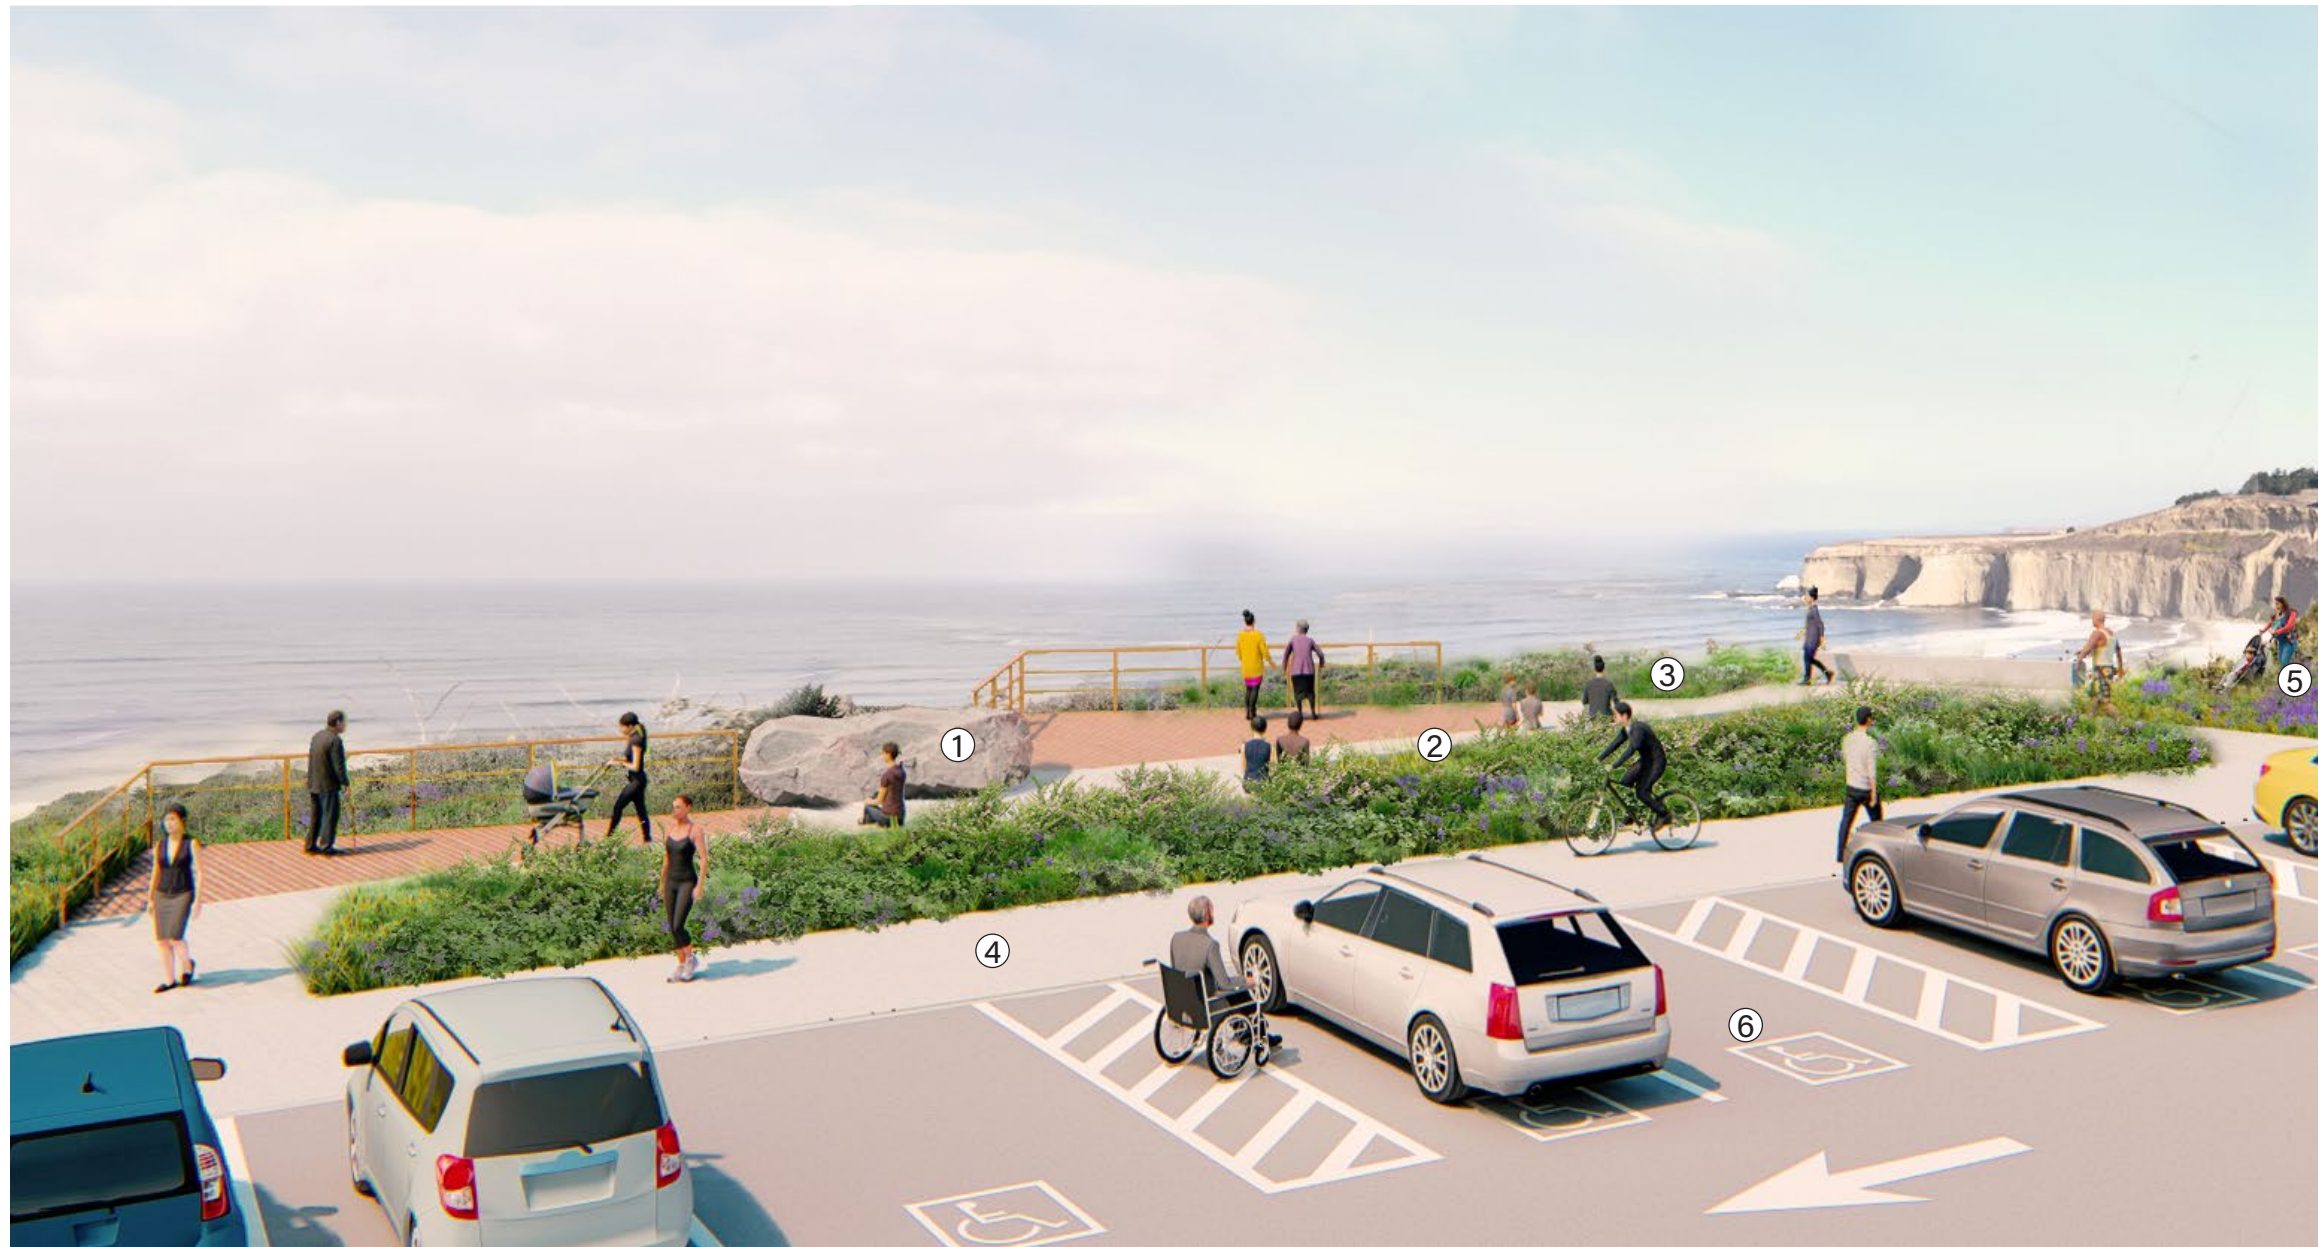
# TOP-OF-BLUFF OVERLOOK POINT

- ① Indigenous Peoples land acknowledgment plaque
- ② Seating areas
- ③ Existing planting to remain
- ④ Paved walkway
- ⑤ Pedestrian access to mid-bluff
- ⑥ ADA Parking
- ⑦ Existing utility poles and wires to be undergrounded or relocated

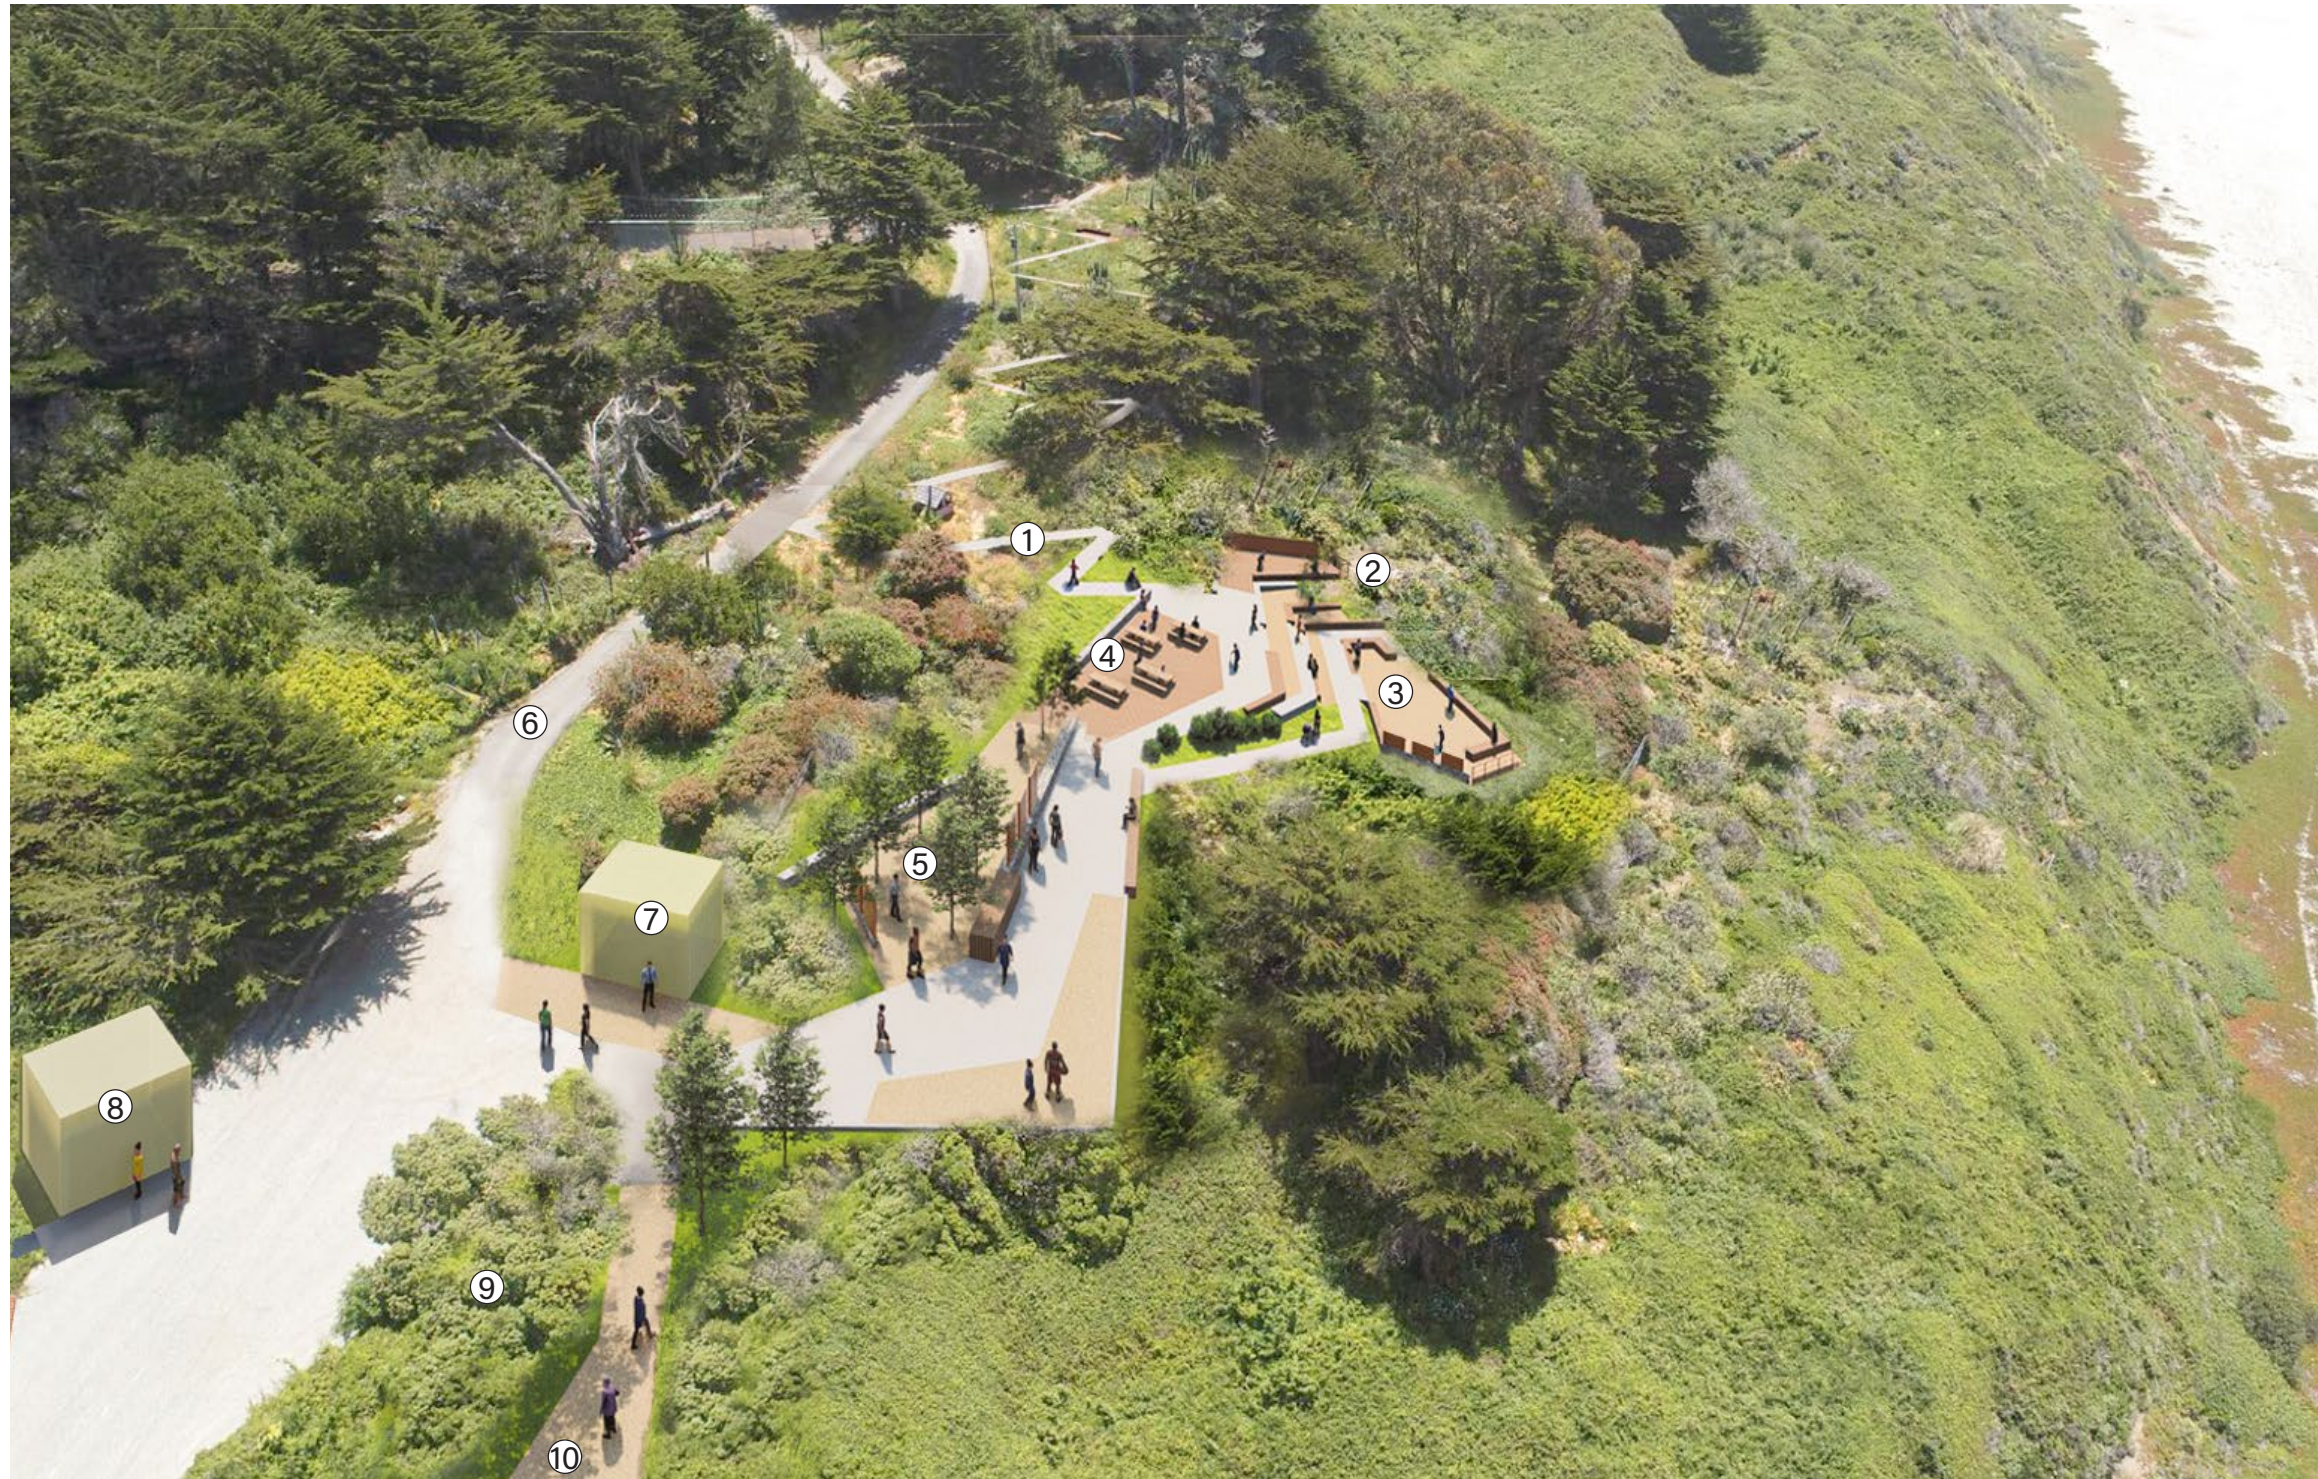
# MID-BLUFF FEATURES

- ① ADA accessible pedestrian path to the mid-bluff
- ② Overlook to beach and southern bluffs
- ③ Tiered seating space, interpretive panels, and overlook point
- ④ Picnic Area
- ⑤ Grove and seating area with interpretive panels
- ⑥ Access driveway for rangers and emergency vehicles
- ⑦ Ranger station and storage area
- ⑧ Public restroom
- ⑨ Restored native planting
- ⑩ Access to beach

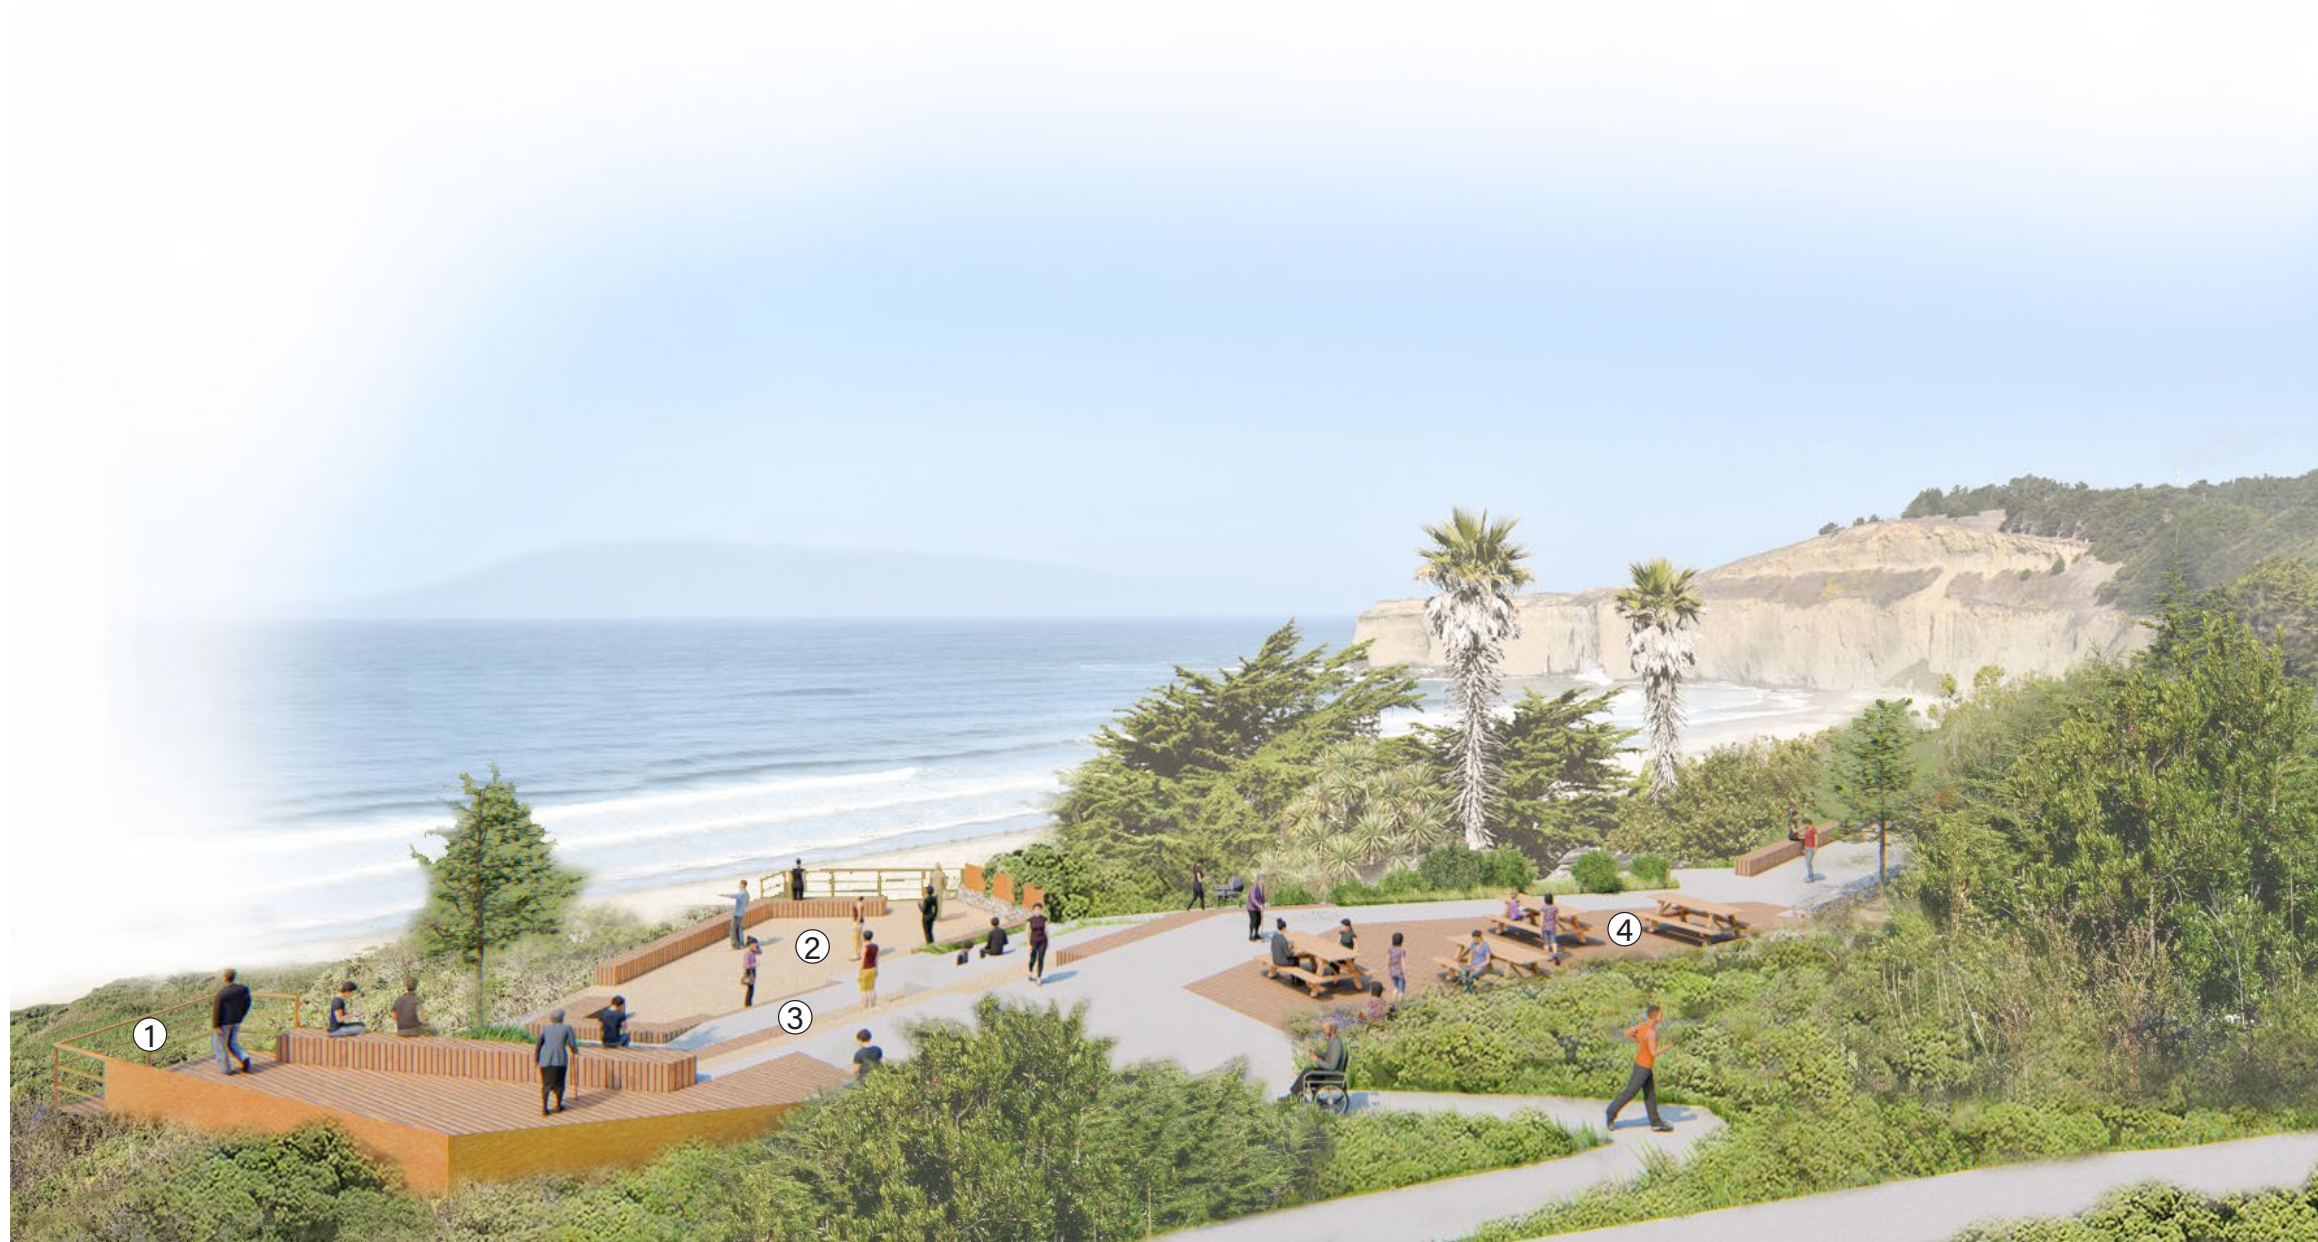
# MID-BLUFF FEATURES

- ① Overlook to beach and southern bluffs
- ② Interpretive panels and overlook point
- ③ Tiered seating
- ④ Picnic area
