# ***Road Safety Audit Report***

## ***Pescadero Creek Road***

San Mateo County, CA  
August 23-25, 2022

## *Pescadero Creek Road Road Safety Audit Report*

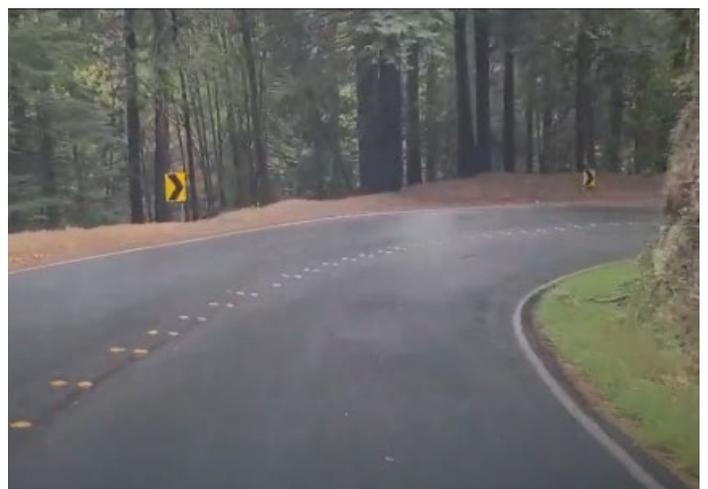
Overall, the roadbed and riding surface is in good condition. Neither base nor sub-base failures are evident. Drainage ditches, inlets, curbing, and gutters appear to be functional and in good condition also. Generally, front slopes are stable and soil-based shoulders are in satisfactory condition and appropriate in height allowing surface water to drain off and away from the pavement. The pavement type varies, either aggregate surface treatment or bituminous wearing surface. Except for horizontal alignment signing and others as noted herein, the overall signing is adequate, and most signs are in a

Photo 2 - Curve Signing La Honda Section (Credit SMC video)

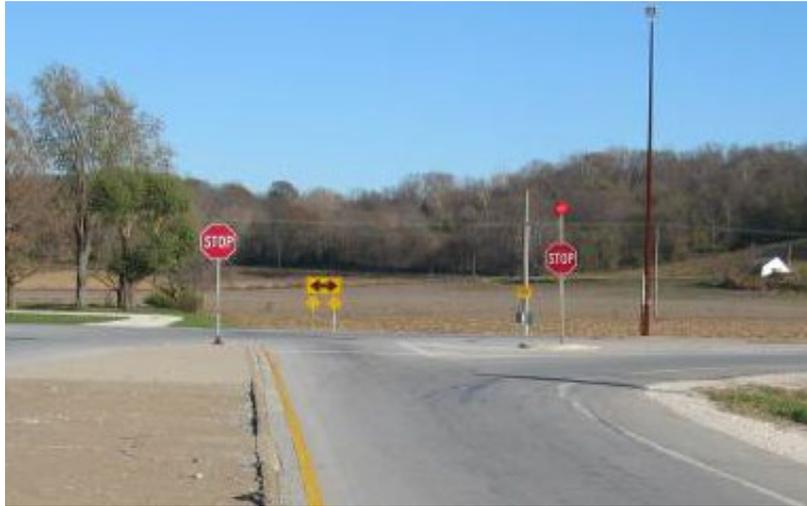
Photo 3 - Example of a supplemental STOP sign mounted on left in a splitter island. Location and photo credit unknown

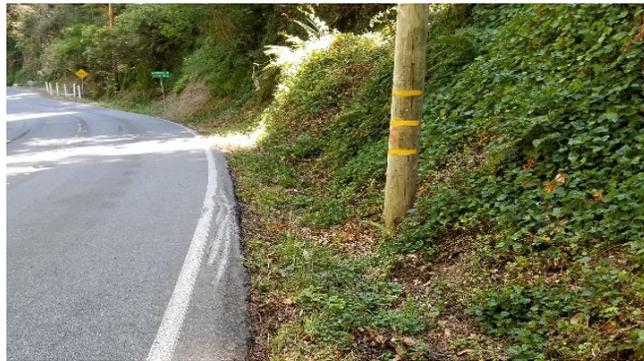
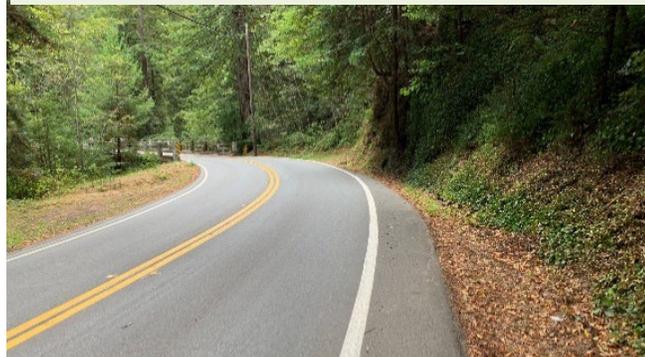
Photos 4 & 5 Loma Mar Section-Top photo 4: some recovery area on approach to curve, shoulder widening. Bottom photo 5: fixed object, no all-weather shoulder, edge drop-off. Photo credit: FHWA

consequences of a lane departure should be used throughout the corridor to improve safety. But more importantly, this tiered approach explanation brings to light the limitation of available options for treatment on PCR. Candidate locations for treatment will be dependent upon the cross-section, ROW availability and influencing topography including the shoulders and slopes. Photo 4 illustrates a more desirable recovery area (Top Photo): presence of a paved shoulder, wider front slope, edge drop-off 2 inches or less, good shoulder height and no man-made fixed objects. Photo #5 depicts a less desirable recovery area, edge drop-off, utility pole, and less shoulder than the previous.

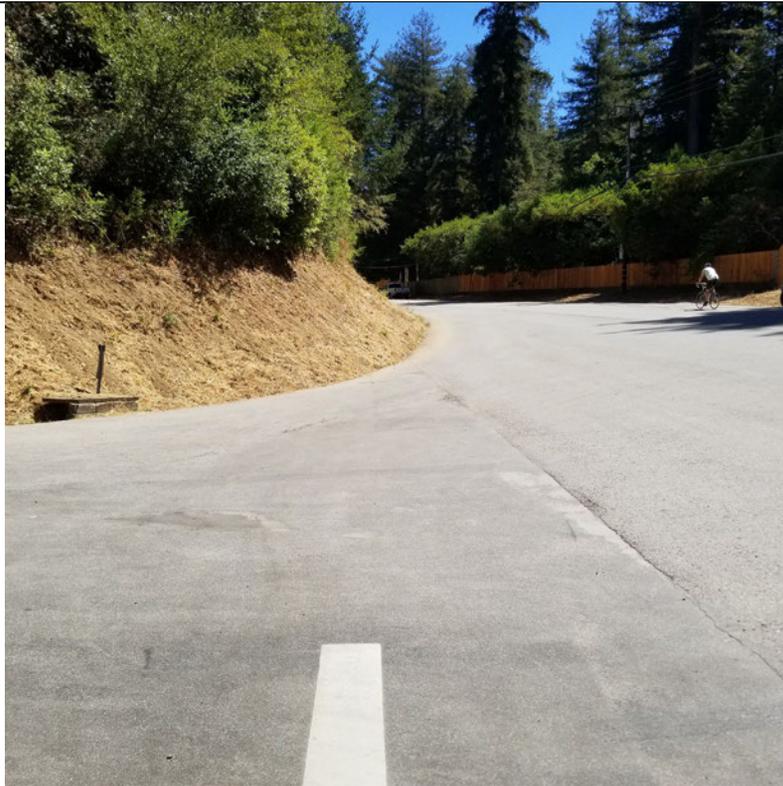
**Observations:** Redwood Drive T-intersection (1 motorcycle crash) - wide throat intersection, lack of channelization, shoulder encroachment, wide pavement, bikes likely use shoulder of 4-6 ft., stop line setback is 10-12 ft from projected edgeline, limiting sight distance looking west, and concern regarding gap acceptance and exposure time to turning traffic leading to intersection conflicts

**Suggested Improvements:** Relocate stop line 5 ft from projected 11 ft. Edgeline. Mark a shorter turn radius and eliminate long tapered edgeline. Double post R1-1 STOP. Consider use of concrete or painted splitter island. Use barrel wrap (black/yellow) around post of splitter island installed STOP. Accommodate transition if needed for shoulder (bike traffic) Effect: Reduce exposure time of turning vehicles, improve sight lines (See Appendix # 7.).

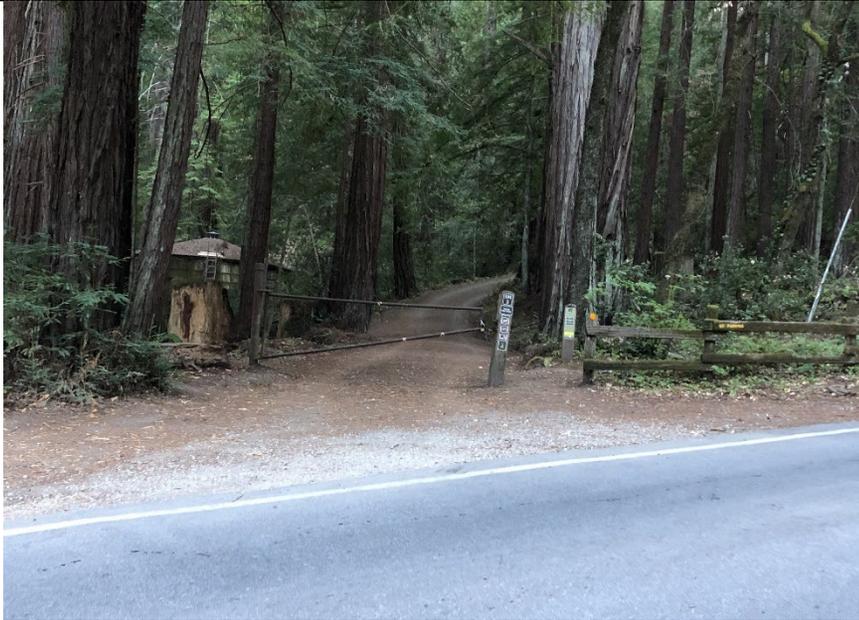
CATEGORY LINK	OBSERVATION # 3	
Vulnerable User Conflicts and Facilities Needs	Trail Connectivity, Parking, Advance Guide/User Services Signing	
<b>SITE SPECIFIC Location</b>	Trailheads and Other Crossings of PCR; (inc. Butano Crk., Memorial Pk., Sam McDonald Pk.)	
Horiz. Alignment	TANGENT <input type="checkbox"/> CURVE <input type="checkbox"/>	
MAINTENANCE SECTION	SECTION Pescadero - La Honda SEGMENT 1 8 & 10 known; others likely	
FREQUENCY Low	SEVERITY High	RISK RATING C
BAND II

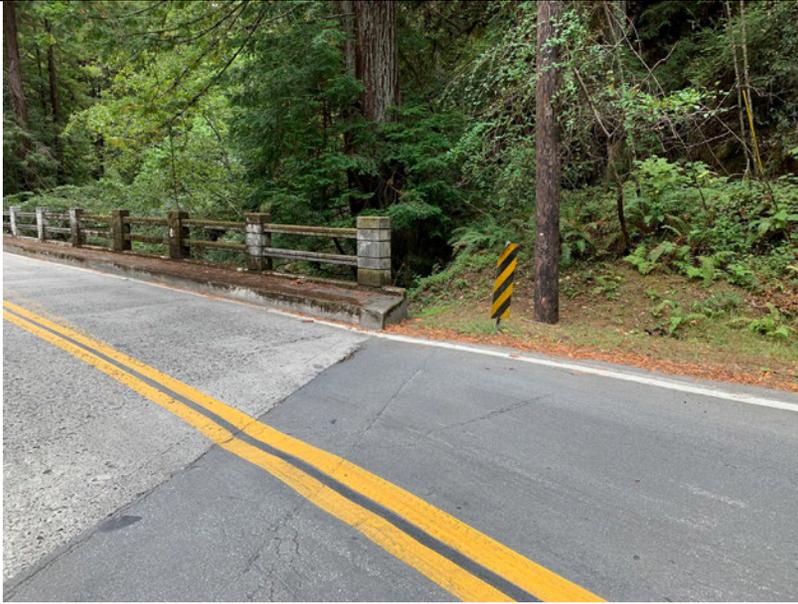
Pescadero Creek Bridge looking westbound (photo credit FHWA)

**Observations:** Neither end of the bridge has a crash attenuator to shield the curb or handrail. Delineation is missing or in poor condition. EB approach is in a curve and lacks delineation for curve.

**Suggested Improvements:** Use bridge post mounted delineators; upgrade hazard markers (placement should be edge of sign parallel with edge of hazard); use fluorescent yellow sheeting; review site for crash attenuators; review need for narrow bridge warning signs and centerline and edgeline supplemental retroreflective, raised pavement markers.

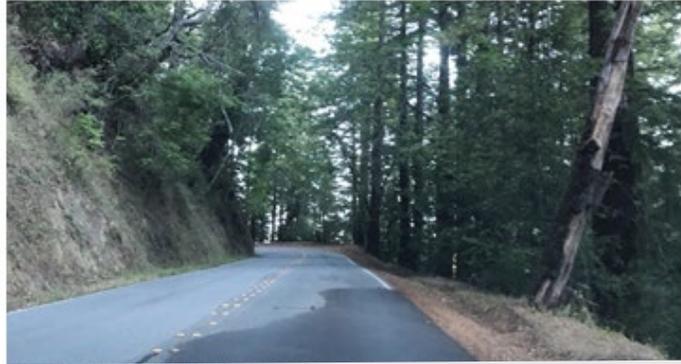
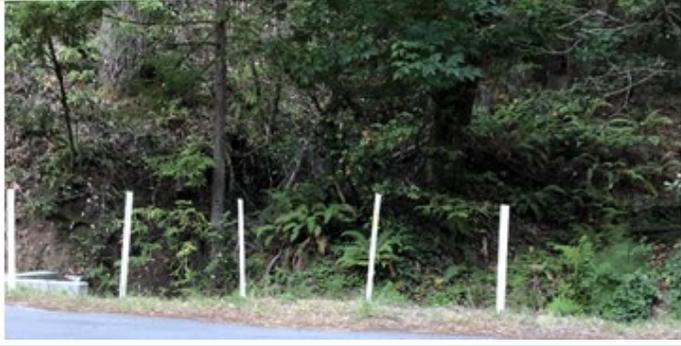
CATEGORY LINK	OBSERVATION # 5	
Lane Departures	Steep Front slopes Lack of Barriers	
<b>SITE SPECIFIC Location</b>	Various	
Horiz. Alignment	TANGENT <input type="checkbox"/> CURVE <input type="checkbox"/>	
MAINTENANCE SECTION	SECTION Loma Mar-La Honda SEGMENT 5-12	
FREQUENCY	SEVERITY	RISK RATING
Low	High	F
BAND I

**Observations:** PCR follows Pescadero Creek which leads to areas where the roadway has steep drop-offs to the creek. These areas do not have any recovery areas. Also due to the topography of the road, there are numerous curves which need to be negotiated. Other curves which may otherwise warrant barrier have berms. Some sites have very steep slopes and practically no shoulder with ravines of visually observed to be about 15-30 ft deep at the toe of about 60-80-degree slope. Others are more forgiving in terms of slope grade.

**Suggested Improvements:** Conduct guardrail needs assessment study. Delineate edge of roadway on outside of curves strongly: Use of raised pavement markers, rumble stripes, post mounted delineators. Since cyclist will likely resist profiled markings, demonstration of greater risk of severe crash accompanies the roadside environment. Profile marking use should be limited to approach and to point of tangent of the curve. Raised pavement markers should be considered at severe curves as a special treatment. Known study locations are shown in Appendix # 6. Reduce speed – add advisory speeds consistent with horizontal alignment study results for posting of correct advisory speed. Investigate bicycle-friendly options that can help prevent lane departures and off-tracking.

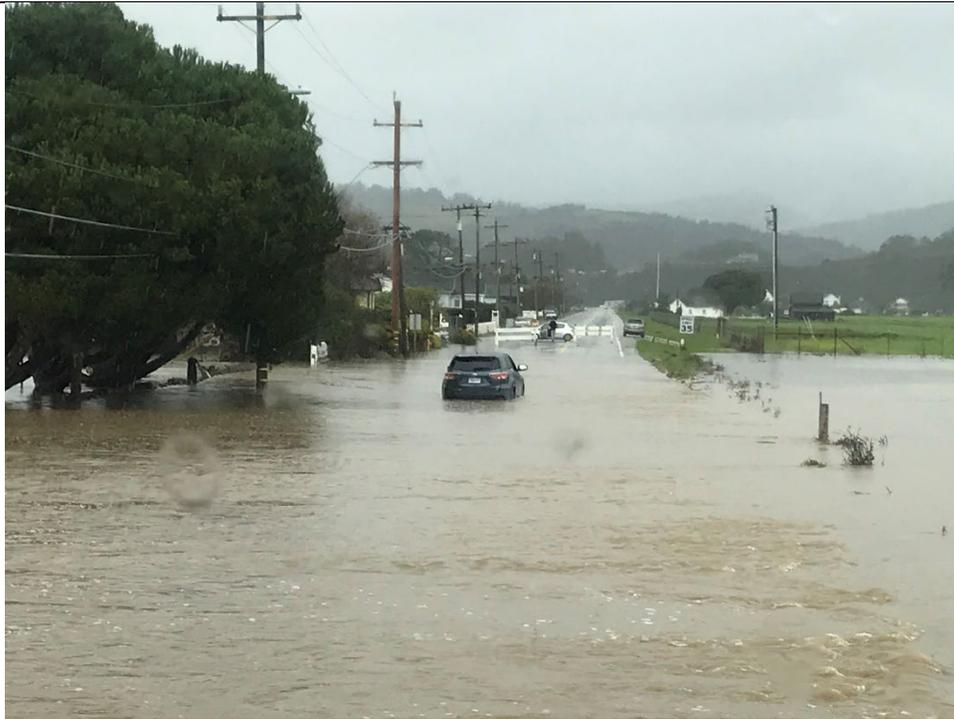
CATEGORY LINK	OBSERVATION # 6	
Vulnerable User Conflicts and Facilities Needs	Flooding of PCR at Butano Creek. Road Closures/Denied Access	
<b>SITE SPECIFIC Location</b>	Flooding of PCR at Butano Creek. Western end of Town of Pescadero	
Horiz. Alignment	TANGENT <input checked="" type="checkbox"/> CURVE <input type="checkbox"/>	
MAINTENANCE SECTION	SECTION Pescadero SEGMENT 2	
FREQUENCY Low	SEVERITY Low	RISK RATING A
BAND III

**Suggested Improvements:** Change roadway profile; Create and/or sign alternate routes in case of flooding; Revisit use of automated warning signs to ensure latest technology is employed (battery backup, fail-safe, and redundant systems). At bridge replacement schedule consider raising the bridge.

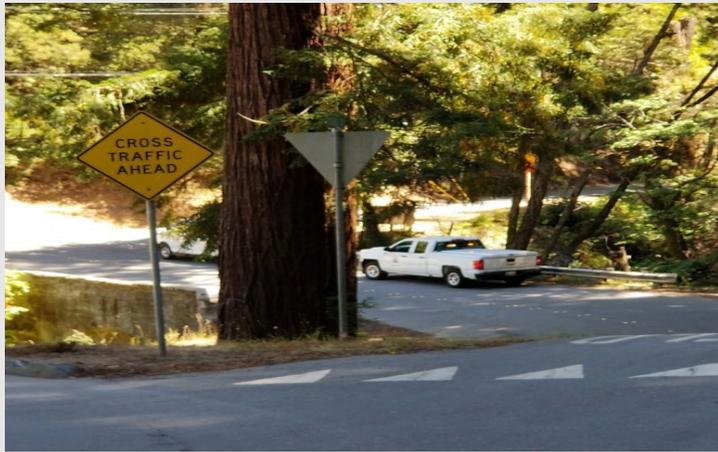
(Photo credit FHWA ) View of connector road to Alpine Road just downstream of point of curve of PCR (EB)

**Observations:** 1) Signing needs. 2) Reducing radii; 3) Enhancements to control type and who has right of way; 4) advanced preview distance; 5) atypical geometry for intersection, high conflict points; 6) increased potential for improper turns or direction of travel; 7) Intersection sight distance

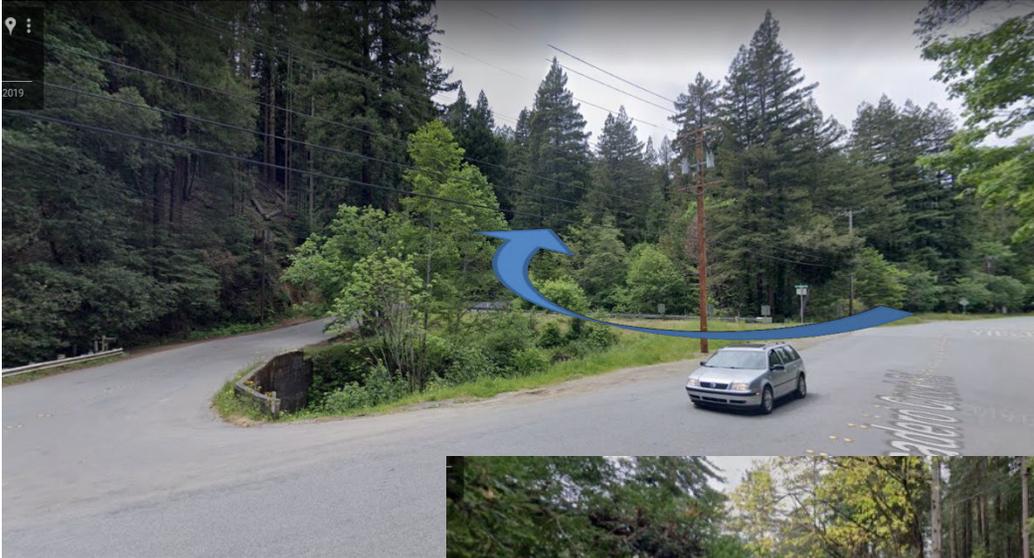
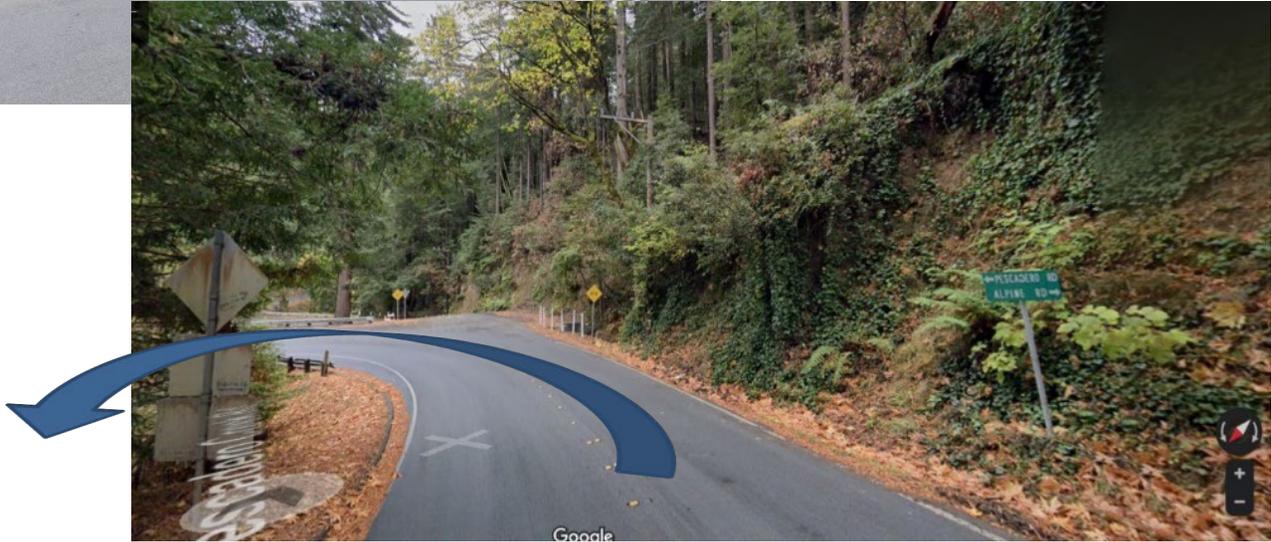
Left: On Alpine looking north at intersection with PCR (Google map showing “Pescadero”) legend is incorrect. PCR is in the background making sharp curve (blue arrow).

Bottom: On PCR looking southeast with Alpine Rd going straight into T-intersection and PCR making sharp turn to left heading east-northeast on PCR (blue arrow)

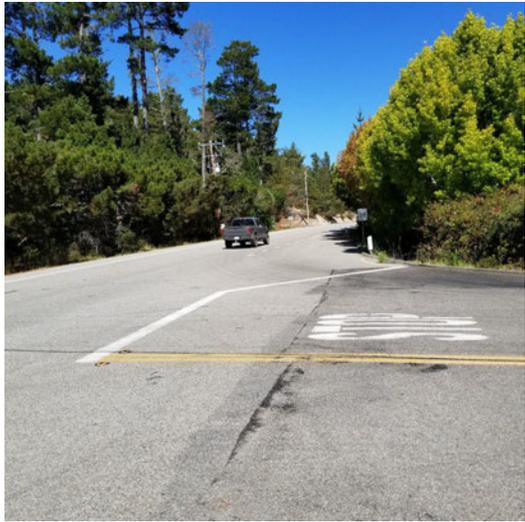
Butano Cut-off Rd. (foreground) looking east downstream on Pescadero. Just east of here the horizontal curve radii reduce substantially, tangents are much shorter, pace speeds decrease, roadway narrows

**Observations:** Motorists may not have sufficient information to know where the roadway alignment and roadside conditions are about to change over a long section of the route. There are places where the roadside clear zone, degree of curvature, superelevation, tangent lengths between curves, etc. change significantly. Drivers can become accustomed to a certain look and feel of the road for more forgiving conditions such as long tangents, large curve radii, generous clear zones, etc. and then not adjust their driving in a timely fashion to compensate for changes to less forgiving roadway/roadside wherever this occurs. In addition, some approaches to sharp curves are longer downgrade tangent sections

**Suggested Improvements:** Consider the use of section or corridor warning signs where the driver receives advance and reminder notices. Depending on the location this could be a change in speed limit, advisory speed, series of sharp curves or winding road. A system of these corridor warning signs should be incorporated with specific warning and regulatory signing to include but not be limited to horizontal curve signing, lane/pavement width transitions, shoulder narrowing or elimination, edge drop-offs, etc. Notable sections: EB travel beginning at Butano Cut-off and WB travel beginning at Alpine Road (and similarly at the change points for these sections for WB travel and EB travel respectively). Consider repeat signing as appropriate every 2 miles and posting distances on all signing. For downgrade tangent sections, consider use of additional upstream warning signs (See Appendix # 3).

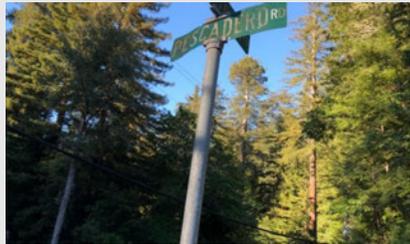
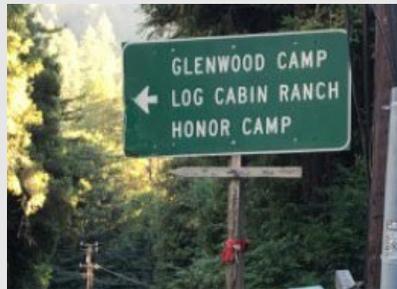
**Observations:** Many intersections lack basic distance, directional guide signs. This includes numbered routes and named streets and roads. Advance street name and route junction signs and directional signs provide motorists with awareness of an intersection and the possibility of slowing/turning traffic signs (see photos). Traffic generator signs are missing or in poor condition

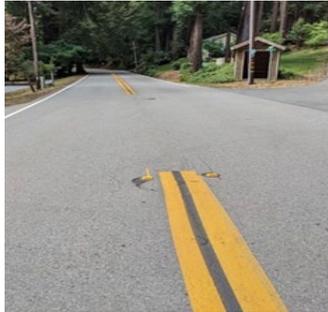
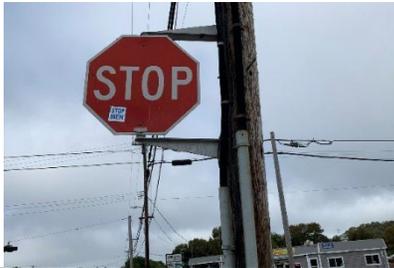
H. Yip Noting narrow space between yellow solid lines

Stop sign mounted on utility pole

Caltrans Responsibility: Improve Street Name Signage – update to latest standards; layouts consistent with SMCDPW plan.

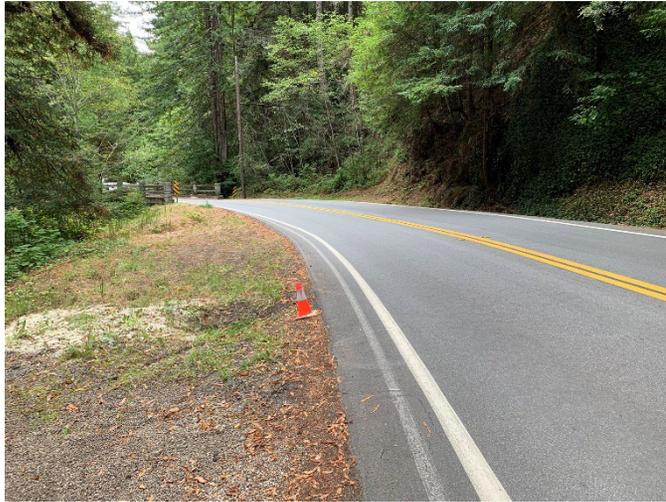
**Observations:** Many of the markings, longitudinal lines i.e., are in very good condition. Some segments on the western half were recently upgraded. But in some locations the edge lines are flush with the edge of the roadway. Centerline markings consist of raised reflective markers, non-reflective markers, or water-borne traffic stripe. Some sections appear to have a variance in the space between the two yellow centerline markings. Specific and site related observations and suggested improvements are contained in this report.

Photo Credit FHWA  
Eastbound view  
near Pescadero Crk.

**Suggested Improvements:** Establish a corridor applied design for edgeline and centerline markings which promote durability, consistency, and longevity. Standard placements should be reviewed to determine if edge lines can be placed closer to the centerline; this will give the appearance of a narrower lane and prevent the striping materials from running off the edge of pavement. For centerlines a space less than the width of the line should be avoided (see photo above) If the standard is 4" solid lines, then consider a 4"-4"-4" pattern or 4"-6"-4" for further lane narrowing perception. The MUTCD simply calls for a discernable space, not specifying a width. Signing plans for guide signs and intersection signing have been address in other Observations (#3, 7, 9). Regulatory signs, R2-1 series, is addressed in Observation #2. Again, a systematic signing plan for the corridor will promote safety and consistency for the users. A signing plan should address the need assessment and use of warning, regulatory and guide signs where safety observations are common and/or known to exist.

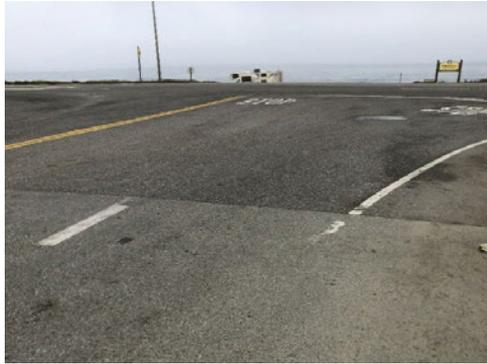
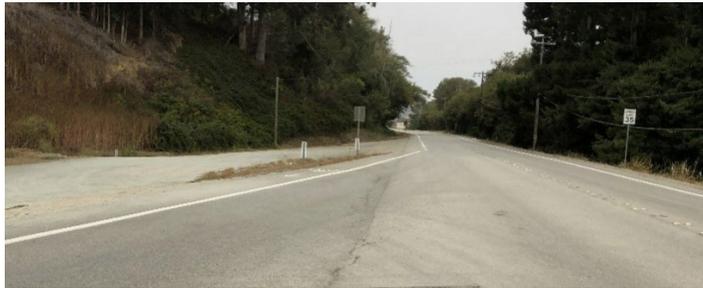
**Observations:** Inconsistent or absence of signs on horizontal curves. Just a few curves out of dozens are signed. Some curves are delineated well using post mounted delineators.

**Suggested Improvements:** Establish a standard horizontal curve warning treatment plan. When certain safety performance criteria (crash frequency, crash rate, fatalities, etc.) pace speed, potential for conflicts and higher risk of injury or crashes, consider the use of substantive safety treatments. Two examples of these are: For curves warranting no horizontal alignment signs per the MUTCD Table 2C-5 or state supplement, the use of post mounted delineators provide both daytime and nighttime guidance (consider retroreflective highway sheeting which is fluorescent yellow on delineators), use wider markings in curves, etc. Refer to other mitigation treatments in the section on Lane Departure and an Example Delineation Plan in the Appendix #4.

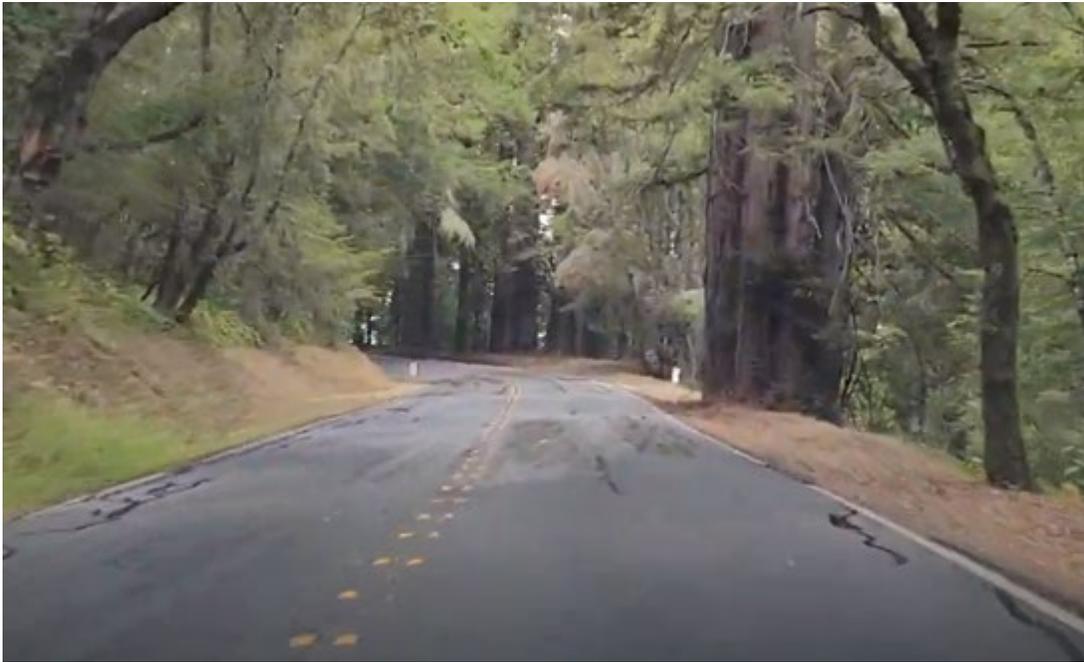
Photo A1 Above (credit: anonymous) Curve with wider than typical shoulder. Location perhaps suitable for a bike pull off

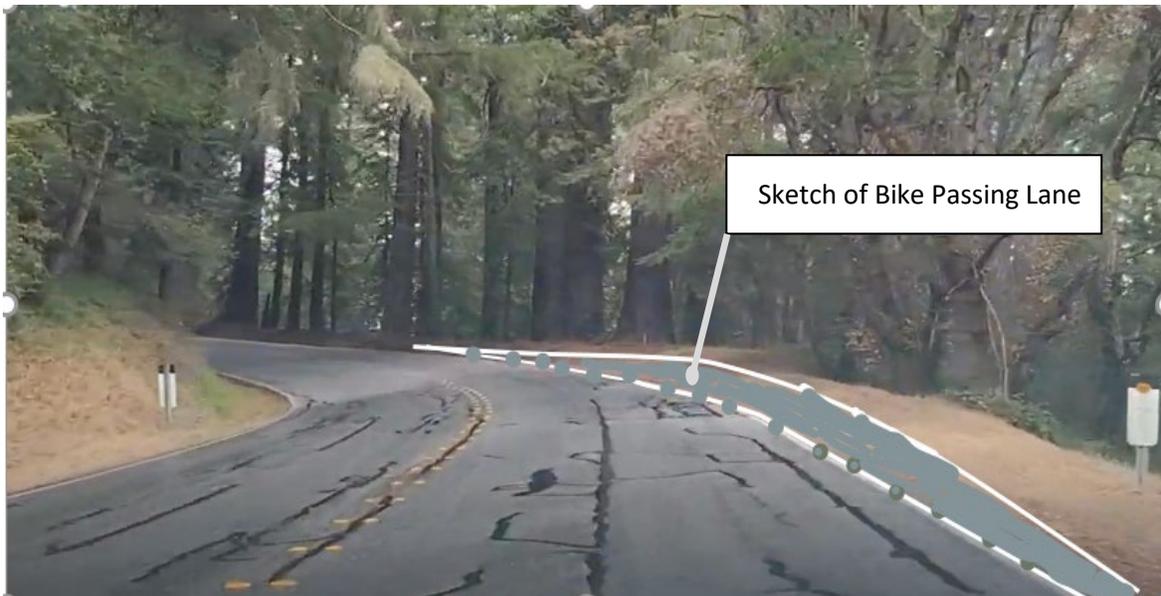
Photo A2 Below (credit anonymous) Closer view (below) showing photo-edited bike pull-off. Design of bike passing lane TBD by SMCDPW

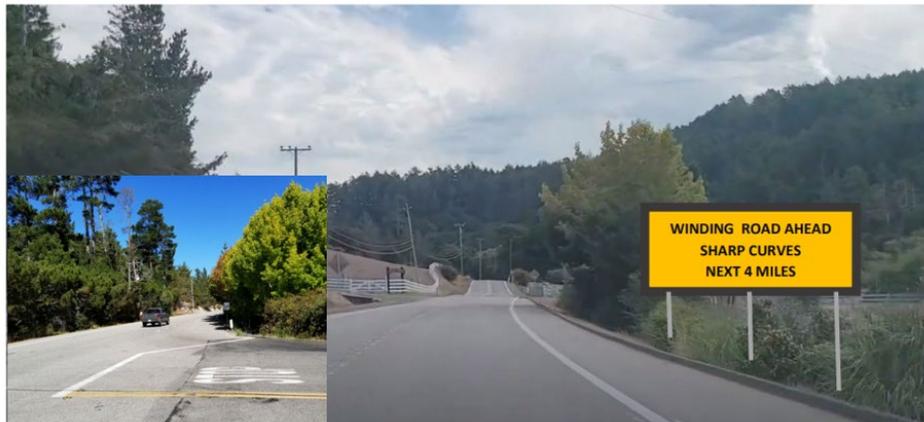
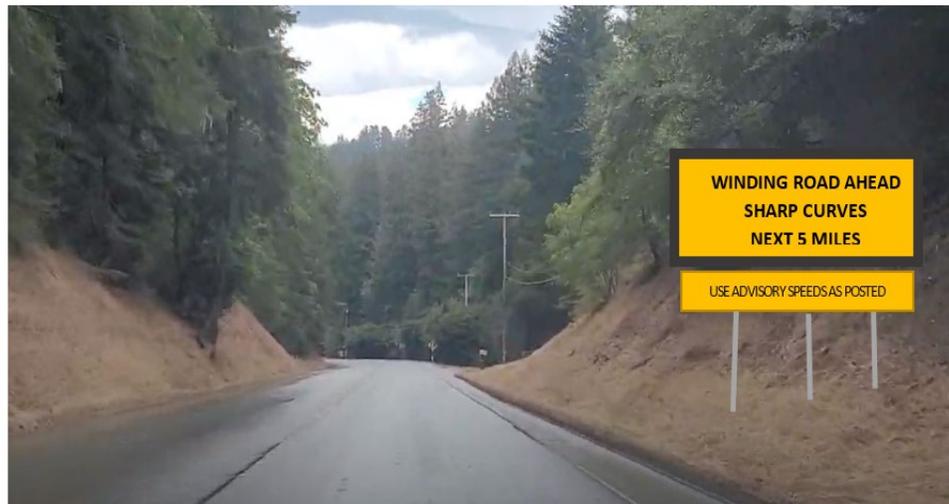
Need for supplemental advance warning signs for downgrade long tangent section approaches to sharp curves. In a few locations the change is evident in ROW, shoulder presence/absent, pavement width, curvature, degree of curvature, driveway frequency, intersection sight distance, etc. Drivers are experiencing a few long stretches of tangent sections between sharp curves, where speeds typically increase. A need exists to warn users. Switchback curve warning sign is seen in distant background (photo A4). This is where a warning sign is needed for change in alignment with reminder after switch back in next tangent section. Sign Design,

Photo A3 (SMC video; inset FHWA) Above Looking eastbound on PCR just east of Butano Cut-off Rd.; inset @ Butano Cut-off Rd.; Photo A4 (SMC video) Below Looking westbound on PCR approach Alpine Road.

legend, shape, mileage, reminders, etc. are the responsibility of SMCDPW. Superimposed signs shown are for illustrative purposes. If conditions warrant, sign message should be repeated in 2-mile increments. Min. letter size 8 in. Highway D Series. Note: These proposed signs as depicted in Photos A3-A4 would supplement, not replace, the necessary warning signs to be installed according to the curve analysis study recently performed by a contractor and speed studies performed by SMCDPW ( See Speed, p. 11, Suggested Improvements 1)-3)).

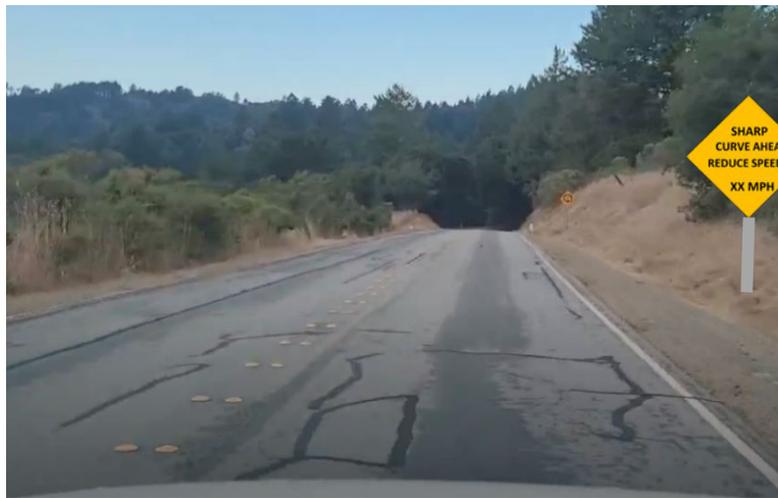
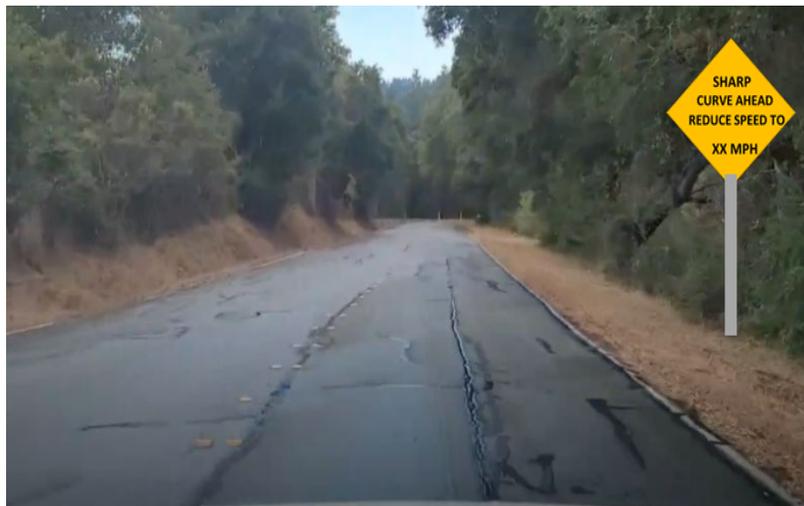
Photo A5 above (Credit SMC video, Reel 2 Horse camp west to Memorial Pk.)  
([37.2970327340414, -122.27758575291675](#)).

Photo A6 (Credit: SMC video) below showing the second tangent past the above curve (photo A5) ([37.295097, -122.279332](#))

Note: These proposed signs as depicted in Photos A5-A6 would supplement, not replace, the necessary warning signs to be installed according to the curve analysis study recently performed by a contractor. Photos below show suggested type of warning sign superimposed onto photos

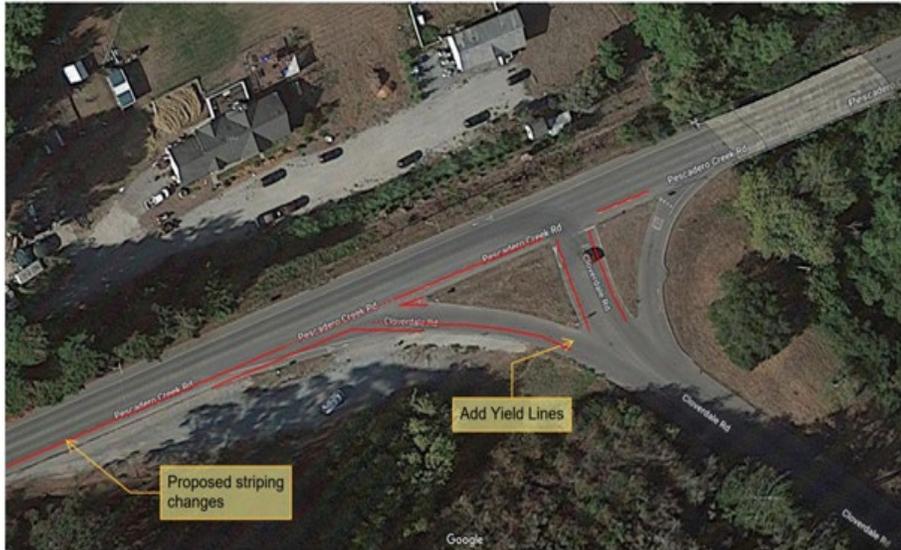
Photo edit showing marking changes suggestions  
Photo A7 - Aerial view below (Source Google Maps)

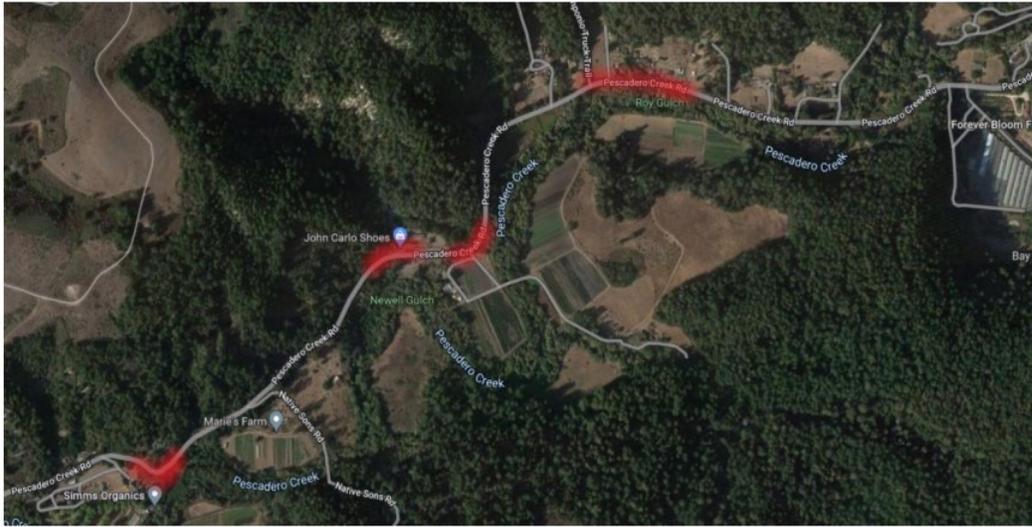
Image A8 - Loma Mar Section , Segment 5,

Numerous locations were noted during the ride-through portion of the field review. A guardrail/barrier analysis should be conducted to determine how many additional sites may be candidates for redirected barrier. Red areas marked on map indicates sites for barrier or other roadway departure countermeasure consideration. Sections are Loma Mar and LaHonda.

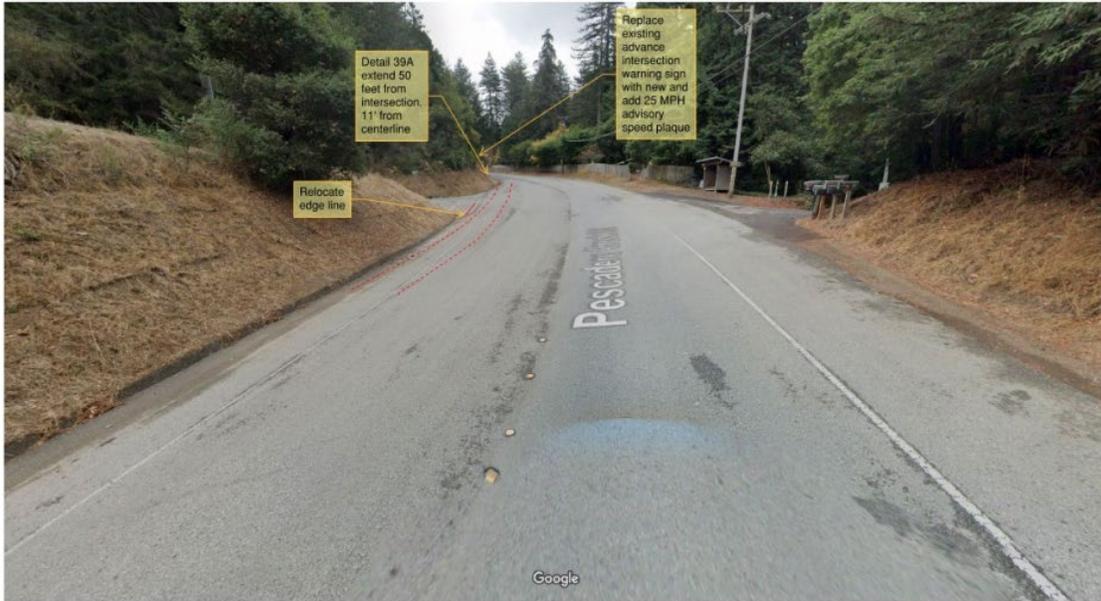
(Photo A11 credit Google Street view)

## 7. Markings Needs at Redwood Dr.
