County of San Mateo - Planning and Building Department

SUNRISE REDWOOD CITY

ASSISTED LIVING FACILITY

REDWOOD CITY, CA

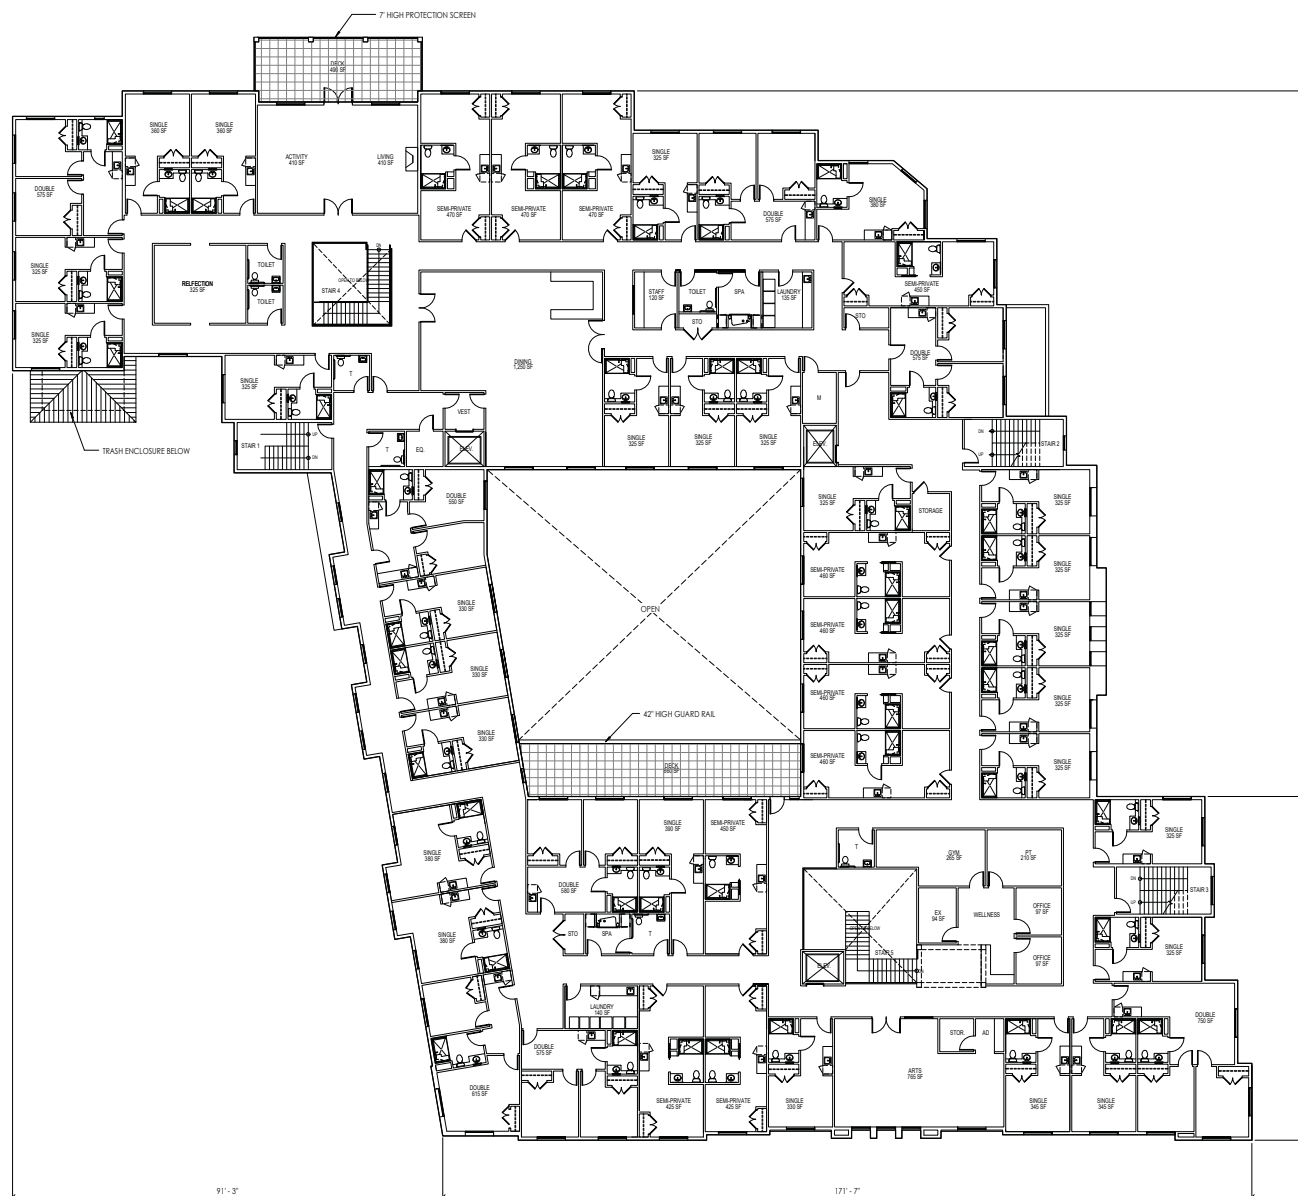
UNIT MIX (SECOND FLOOR):	
SINGLE	27
DOUBLE	08
SEMI-PRIVATE	11
TOTAL	46

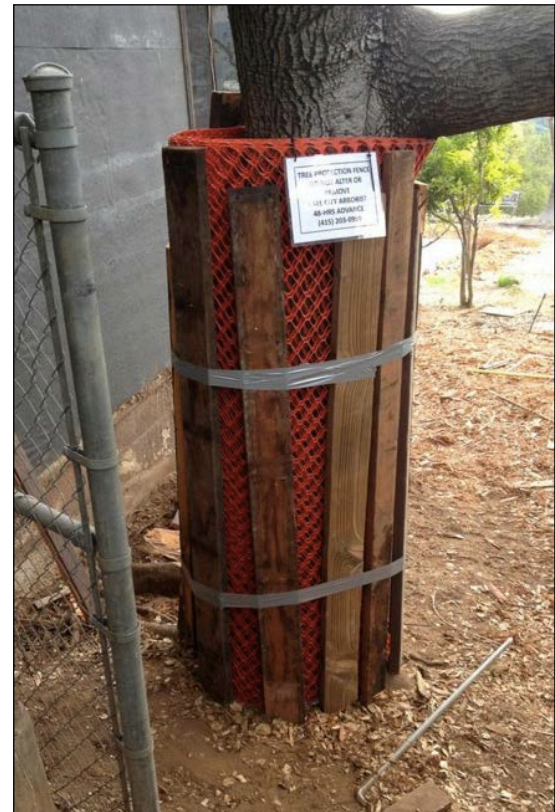
Prior to any site demolition work commencement, **install trunk buffers around the trunks of all of the subject trees assessed in this report that are to be retained.** Use at least one (1) entire roll of orange plastic snow fencing, wrapping the roll around the lowermost eight feet of the trunk of each tree. Place 2X4 wood boards or waste wood pieces standing upright, side by side, over the plastic buffer, and secure the boards with duct tape per the sample spec image above right.

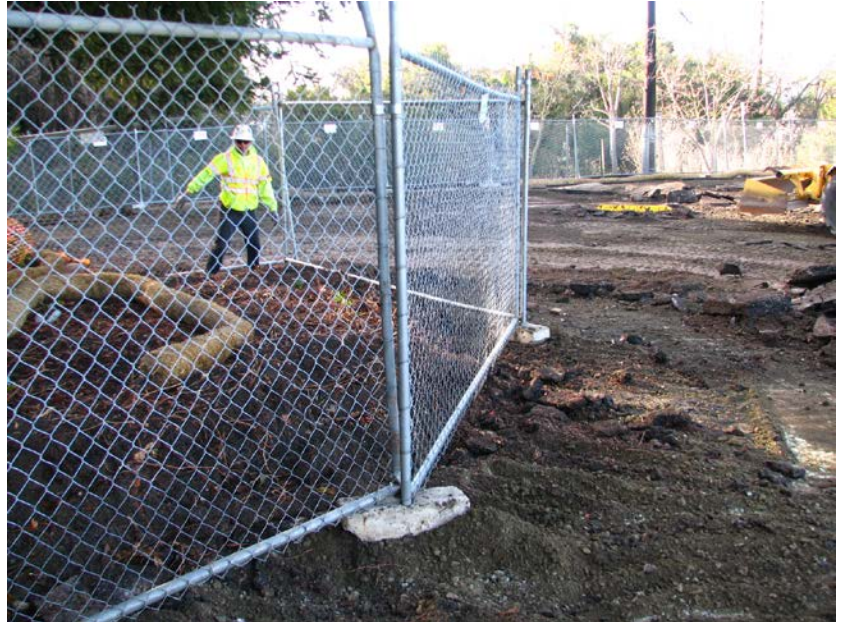
Pre-demolition fence:

This fencing must be erected prior to any heavy machinery traffic or construction material arrival on site.

The protective fencing must not be temporarily moved during construction. No materials, tools, excavated soil, liquids, substances, etc. are to be placed or dumped, even temporarily, inside the root protection zone or "RPZ".

The general route for fencing erection should be at least 15 to 30 feet radius offset from each tree trunk, or the canopy dripline, or as far as possible offset from trunk to allow for proposed work to occur.

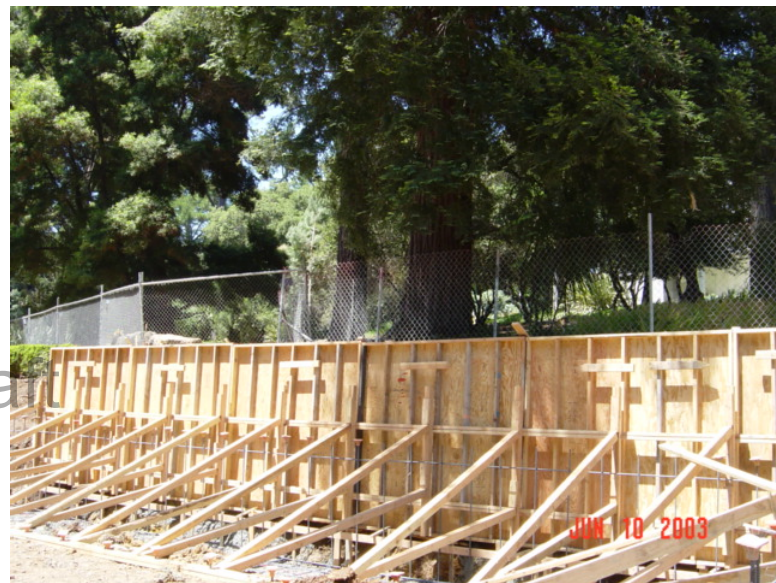
Oaks #1 through #7 likely exhibit horizontally extended root systems that extend 30 to 40 feet radius (or more) southward and westward, coursing through the old base rock just underneath the existing asphalt parking lot.

It is suggested that the project team consider modification of the proposed building footprint exterior foundation work limit, and the underground parking garage excavation work limit which coincides exactly with the building exterior. The modification suggested is a push to the south and/or west to allow for better lateral offset distance between the oaks' root systems and the excavation cut which will destroy 100% of all lateral woody and absorbing root mass at that distance.

A suggested minimum distance is 25 to 30 feet from excavation cut to tree trunks.

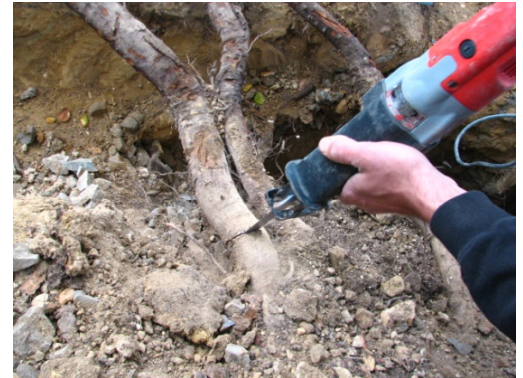
If **woody roots measuring greater than 1-inch in diameter** are encountered within 25-feet of any tree being retained during site work, contractors shall immediately alert the project arborist, and shall proceed to sever roots at right angles to the direction of root

growth using sharp hand tools such as professional grade loppers, hand shears, chain saw, A/C sawzall, or other tools only under his/her direct supervision. See spec images at right. Note that a Sawzall blade indicating use for "bimetal" or "demolition" is typically not a good choice for this work. Instead, opt for a relatively large-toothed blade that indicates use for "pruning" or "wood" (see images at right).

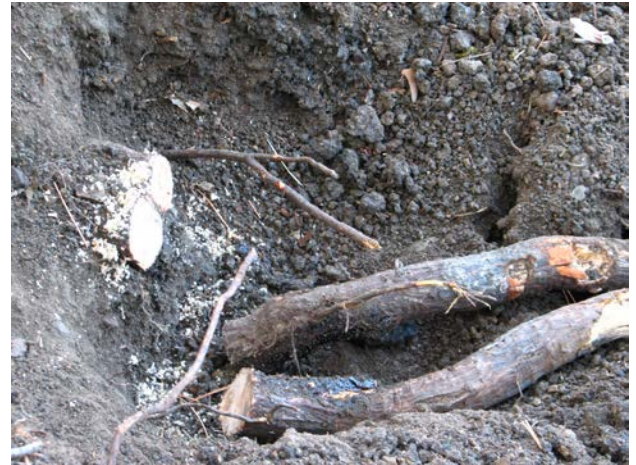
Woody roots shall not be shattered or broken in any way as a result of site activities. Shattered or broken areas shall be hand dug back into clear healthy root tissue and re-severed at right angles to root growth direction under the direct supervision of the project arborist (PA). Immediately (same day) backfill over roots and heavily irrigate (same day) after backfill to saturate the uppermost 24 inches of the soil profile.

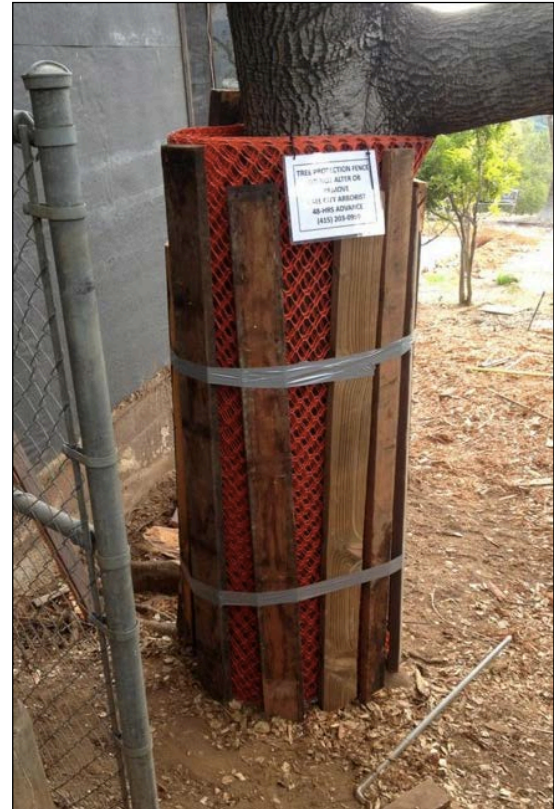
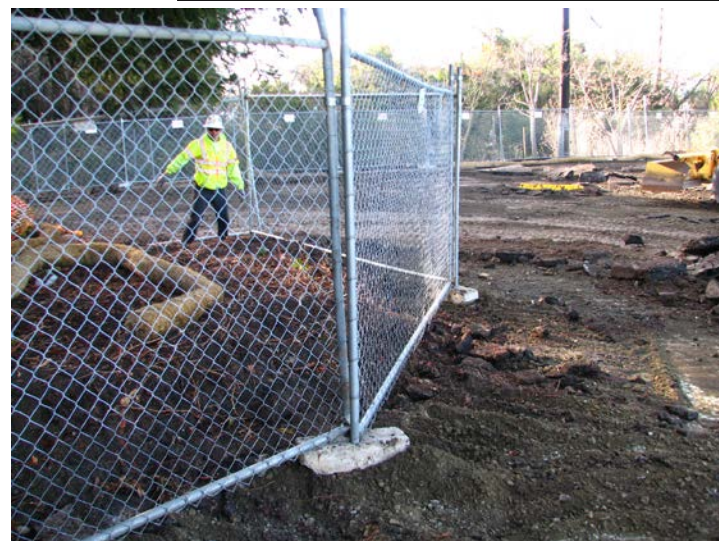
Erect five-foot tall chain link fence on seven-foot long, two-inch diameter iron tube posts pounded 24 inches into the ground. Alternatively, use chain link fence panels set on small moveable concrete block footings and affixed to rebar or steel layout stakes pounded into the ground at the end of each fence panel to make the fence perimeters rigid and immobile (see sample image at right).

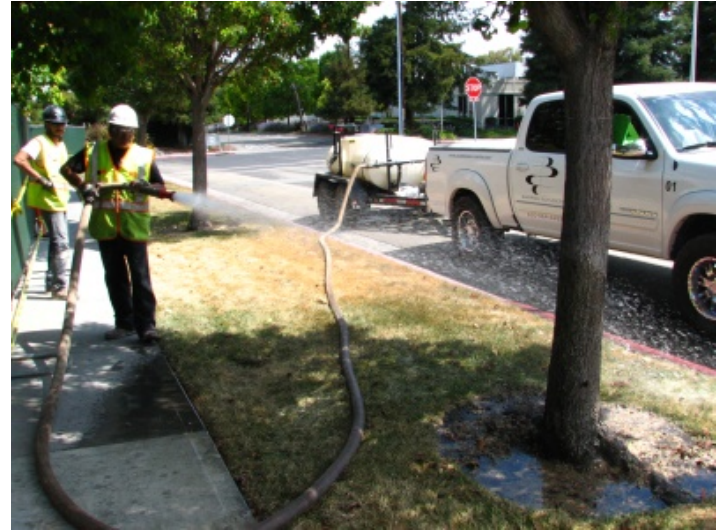
Apply temporary irrigation to certain specified trees being retained, at a frequency and duration or total output to be specified by the project arborist (PA).

Method of water delivery can be soaker hose, emitter line, garden hose trickle, water truck, tow-behind water tank with spray apparatus, etc.

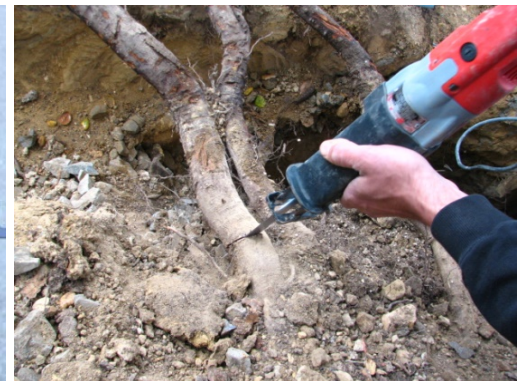
If **woody roots measuring greater than 1-inch in diameter** are encountered within 25-feet of any tree being retained during site work, contractors shall immediately alert the project arborist, and shall proceed to sever roots at right angles to the direction of root growth using sharp hand tools such as professional grade

loppers, hand shears, chain saw, A/C sawzall, or other tools only under his/her direct supervision. See spec images at right. Note that a Sawzall blade indicating use for "bimetal" or "demolition" is typically not a good choice for this work. Instead, opt for a relatively large-toothed blade that indicates use for "pruning" or "wood" (see images at right).
